Access Compliance Report

Public Rights-of-Way

(Curb Ramps)

Intersection ID: 45827	Main Street: CHRISTENBURY_RD	Cross Street: CHRISTENBURY_HILLS_LN	Location: W
ADA ID: 399491CBEF8D	Ramp Type: Perp	Initial Pass/Fail: Fail	Overall Compliance: No
Severity Score: 42.5			
Codes/Mitigation Info/Possible Solution		Field Measurements/Component Compliance

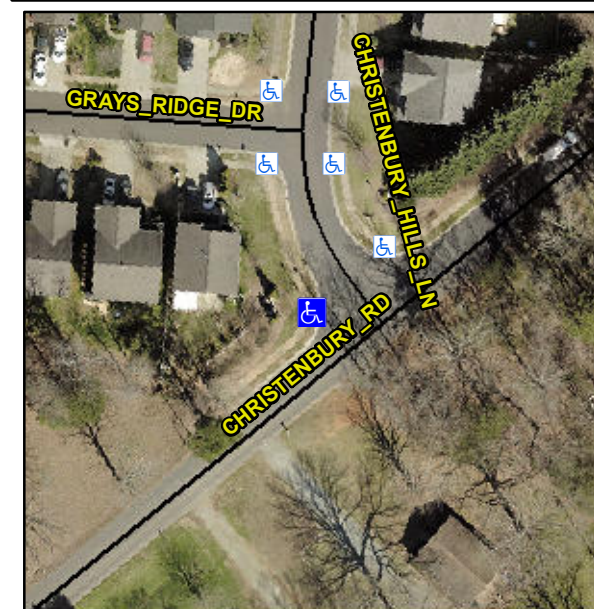
Not Found, R304.5.1, R304.2.2

Compliance	Description	Data	Compliance	Description	Data
N/A	Ramp Length (in)	46.0	No	Ramp Slope (%)	18.7
No	Ramp Width (in)	34.0	Yes	Ramp XSlope (%)	1.1
N/A	Flare Type LT	N/A	N/A	Flare Type RT	N/A
N/A	Flare Slope LT (%)	N/A	N/A	Flare Slope RT (%)	N/A
N/A	Flare Traversable LT?	N/A	N/A	Flare Traversable RT?	N/A
N/A	Landing Length (in)	N/A	N/A	DWS Provided?	N/A
N/A	Landing Width (in)	N/A	N/A	DWS Contrast?	N/A
N/A	Landing Slope (%)	N/A	N/A	DWS Length (in)	N/A
N/A	Landing X Slope (%)	N/A	N/A	DWS Full Width?	N/A
N/A	Landing Curb? (Y/N)	N/A	N/A	DWS Offset (in)	N/A
N/A	Shared Landing?	N/A			
N/A	Gutter Ponding?	N/A	N/A	Gutter Slope (%)	N/A
N/A	Gutter Lip Ht (in)	N/A	N/A	Gutter X Slope (%)	N/A
N/A	Painted X Walk1?	No	N/A	Painted X Walk2?	N/A
	X Walk 1 Direction	To NE		X Walk 2 Direction	N/A
N/A	X Walk 1 Width (in)	N/A	N/A	X Walk 2 Width (in)	N/A
	X Walk 1 Slope (%)	0.9		X Walk 2 Slope (%)	N/A
	X Walk 1 X Slope (%)	1.0		X Walk 2 X Slope (%)	N/A

N/A	Ramp inside XWalk1?	N/A	N/A	Ramp inside XWalk2?	N/A
	Road Slope (%)	N/A	N/A	Clear Space?	N/A
	Road X Slope (%)	N/A	N/A	Clear Space to XWalk (in)	N/A
N/A	Any Obstructions?	N/A	N/A	Storm Grate/Utility Hazard?	N/A
	Obstruction Type			Storm Grate/Utility Type	
		N/A			N/A
			Yes	Surface Condition? (G/P)	Good

Possible Solutions:

Remove & Replace Entire Ramp.

Total Cost: \$ 1850.00
