Access Compliance Report

Public Rights-of-Way (Curb Ramps)

Intersection ID: 2908	Main Street: CORNER_CT	Cross Street: MEADOWVIEW_HILLS_DR	Location: NE
ADA ID: 3999B1D4F9D1	Ramp Type: PerpDiag	Initial Pass/Fail: Fail	Overall Compliance: No
Severity Score: 25			
Codes/Mitigation Info/Possible Solution		Field Measurements/Component Compliance

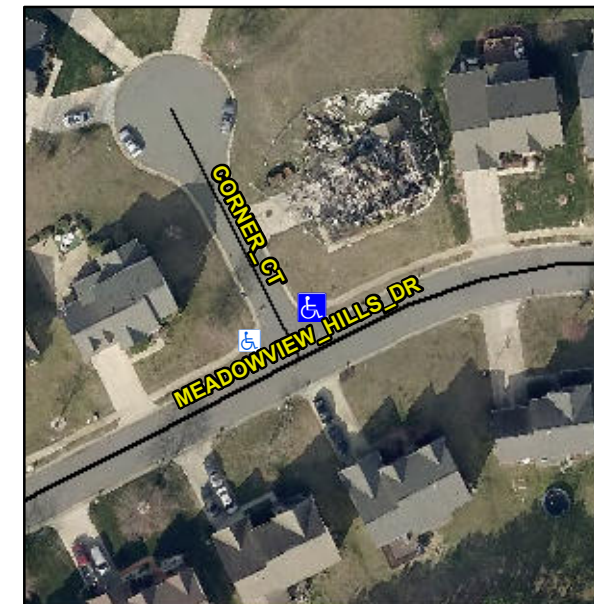
Not Found, R304.2.2, R304.5.3

Compliance	Description	Data	Compliance	Description	Data
N/A	Ramp Length (in)	45.0	No	Ramp Slope (%)	9.4
Yes	Ramp Width (in)	53.0	No	Ramp XSlope (%)	6.9
N/A	Flare Type LT	N/A	N/A	Flare Type RT	N/A
N/A	Flare Slope LT (%)	N/A	N/A	Flare Slope RT (%)	N/A
N/A	Flare Traversable LT?	N/A	N/A	Flare Traversable RT?	N/A
N/A	Landing Length (in)	N/A	N/A	DWS Provided?	N/A
N/A	Landing Width (in)	N/A	N/A	DWS Contrast?	N/A
N/A	Landing Slope (%)	N/A	N/A	DWS Length (in)	N/A
N/A	Landing X Slope (%)	N/A	N/A	DWS Full Width?	N/A
N/A	Landing Curb? (Y/N)	N/A	N/A	DWS Offset (in)	N/A
N/A	Shared Landing?	N/A			
N/A	Gutter Ponding?	N/A	N/A	Gutter Slope (%)	N/A
N/A	Gutter Lip Ht (in)	N/A	N/A	Gutter X Slope (%)	N/A
N/A	Painted X Walk1?	No	N/A	Painted X Walk2?	No
	X Walk 1 Direction	To W		X Walk 2 Direction	To S
N/A	X Walk 1 Width (in)	N/A	N/A	X Walk 2 Width (in)	N/A
	X Walk 1 Slope (%)	3.9		X Walk 2 Slope (%)	1.5
	X Walk 1 X Slope (%)	2.7		X Walk 2 X Slope (%)	6.4

N/A	Ramp inside XWalk1?	N/A	N/A	Ramp inside XWalk2?	N/A
	Road Slope (%)	7.7	N/A	Clear Space?	N/A
	Road X Slope (%)	4.9	N/A	Clear Space to XWalk (in)	N/A
N/A	Any Obstructions?	N/A	N/A	Storm Grate/Utility Hazard?	N/A
	Obstruction Type			Storm Grate/Utility Type	
		N/A			N/A
		Yes		Surface Condition? (G/P)	Good

Possible Solutions:

Remove & Replace Curb Ramp With Two New Directional Ramps or Equivalent.
