Access Compliance Report Public Rights-of-Way (Curb Ramps)

Intersection ID: 8051 Main Street: AUSTIN_DR Cross Street: MONTEITH_DR Location: NE

ADA ID: 399B4576D164 Ramp Type: BlendTrans1 Initial Pass/Fail: Fail Overall Compliance: No Severity Score: 8.75

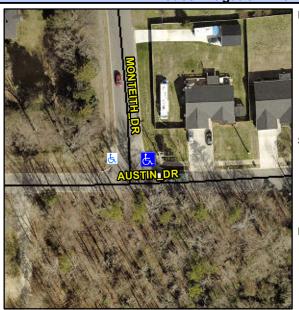
PROW/ADA:
Not Found, R304.5.1

| Compliance Description | | Data | Comp | liance Description | Data |
|---|---|---|---|---|---|
| No | Ramp Width (in) | 38.0 | Yes | BlendTrans XSlope (%) | 0.3 |
| | | | No | Curb Slope (%) | 13.0 |

Remove & Replace Curb Ramp With
Two New Directional Ramps or
Equivalent.

\$ 3200.00
