Access Compliance Report

Public Rights-of-Way

(Curb Ramps)

Intersection ID: 15072	Main Street: DILWORTH_RD_EAST	Cross Street: E WORTHINGTON AV	Location: E
ADA ID: 399F4300AC7A	Ramp Type: Directional1	Initial Pass/Fail: Fail	Overall Compliance: No
			Severity Score: 26.25

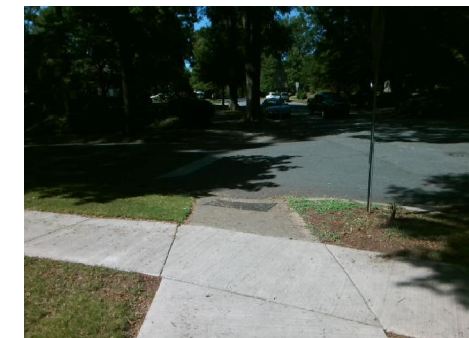
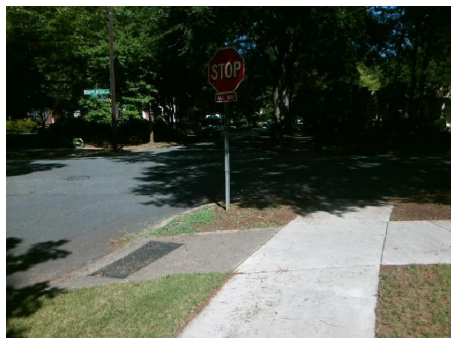
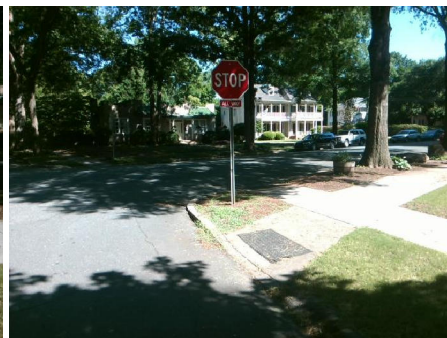
Compliance	Description	Data	Compliance	Description	Data
N/A	Ramp Length (in)	84.0	N/A	Grade Break?	N/A
Yes	Ramp Width (in)	48.0	N/A	Grade Break Slope (%)	0.0
No	Ramp Slope (%)	12.6	N/A	Grade Break XSlope (%)	0.0
No	Ramp XSlope (%)	2.8			
N/A	Flare Type LT	N/A	N/A	Flare Type RT	N/A
N/A	Flare Slope LT (%)	N/A	N/A	Flare Slope RT (%)	0.0
N/A	Flare Traversable LT?	N/A	N/A	Flare Traversable RT?	N/A
N/A	Landing Length (in)	0.0	N/A	DWS Provided?	N/A
N/A	Landing Width (in)	0.0	N/A	DWS Contrast?	N/A
N/A	Landing Slope (%)	0.0	N/A	DWS Length (in)	N/A
N/A	Landing X Slope (%)	0.0	N/A	DWS Full Width?	N/A
N/A	Landing Curb? (Y/N)	N/A	N/A	DWS Offset LT (in)	N/A
N/A	Shared Landing?	N/A	N/A	DWS Offset RT (in)	N/A
N/A	Gutter Ponding?	0.0	N/A	Gutter Slope (%)	N/A
N/A	Gutter Lip Ht (in)	0.0	N/A	Gutter X Slope (%)	N/A
N/A	Painted X Walk1?	No		Road Slope (%)	4.9
	X Walk 1 Direction	To S		Road X Slope (%)	4.0
	X Walk 1 Width (in)	N/A		Clear Space?	N/A

X Walk 1 Slope (%)	4.9	N/A	Clear Space to XWalk (in)	N/A
	X Walk 1 X Slope (%)	4.0	N/A	Storm Grate/Utility Hazard?	N/A
N/A	Ramp inside XWalk1?	N/A		Storm Grate/Utility Type	
N/A	Any Obstructions?	N/A			N/A
	Obstruction Type		Yes	Surface Condition? (G/P)	Good
			N/A	Curb Slope (%)	8.7

Possible Solutions:

Remove & Replace Entire Ramp.
