# Access Compliance Report

## Public Rights-of-Way

| Intersection ID: 48311 | Main Street: TRILLIUM_FIELDS_DR | Cross Street: GREEN_CLOVER_DR | Location: SE |
| ADA ID: 39A267419E28 | Ramp Type: BlendTrans1 | Initial Pass/Fail: Fail | Overall Compliance: No |

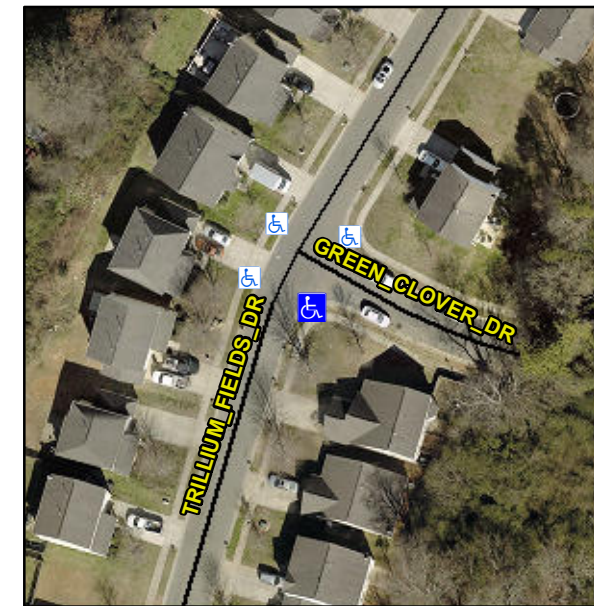
**Not Found, R304.5.1, R304.5.3**

| Compliance | Description | Data | Compliance | Description | Data |
|---|---|---|---|---|---|
| No | Ramp Width (in) | 47.0 | No | BlendTrans XSlope (%) | 2.1 |

**Remove & Replace Curb Ramp With Two New Directional Ramps or Equivalent.**

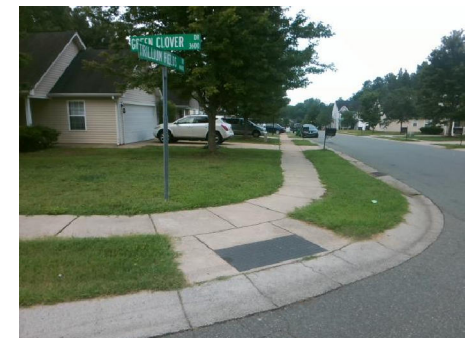
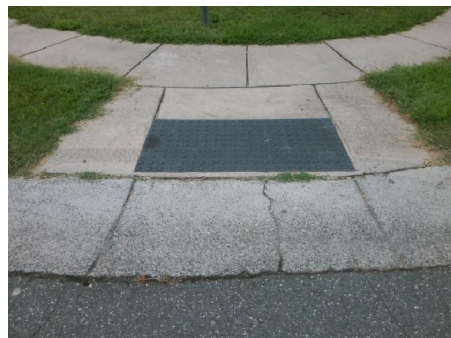
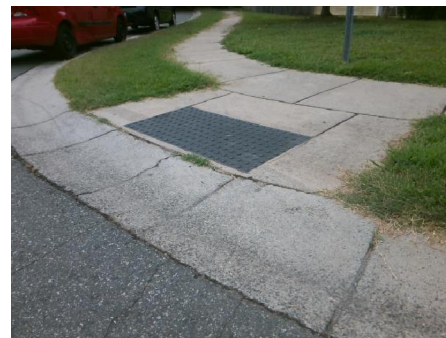
| Compliance | Description | Data | Compliance | Description | Data |
|---|---|---|---|---|---|
| | | | No | Curb Slope (%) | 12.4 |
