# Access Compliance Report

## Public Rights-of-Way

Intersection ID: 44299	Main Street: PEACH_PLACE_LN	Cross Street: ROCKWOOD_RD	Location: SW
ADA ID: 39B29CF33B64	Ramp Type: PerpDiag	Initial Pass/Fail: Fail	Overall Compliance: No
		Severity Score: 25

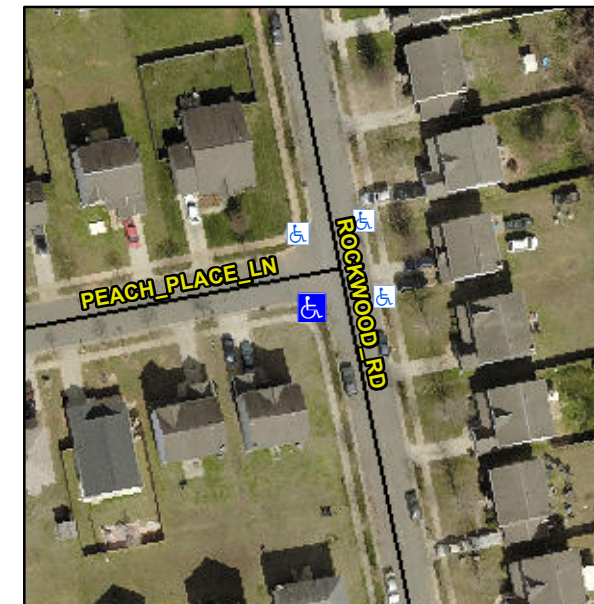
**Not Found, R304.5.3**

Compliance	Description	Data	Compliance	Description	Data
N/A	Ramp Length (in)	48.5	Yes	Ramp Slope (%)	5.2
Yes	Ramp Width (in)	48.0	No	Ramp XSlope (%)	9.3
N/A	Flare Type LT	N/A	N/A	Flare Type RT	N/A
N/A	Flare Slope LT (%)	N/A	N/A	Flare Slope RT (%)	N/A
N/A	Flare Traversable LT?	N/A	N/A	Flare Traversable RT?	N/A
N/A	Landing Length (in)	N/A	N/A	DWS Provided?	N/A
N/A	Landing Width (in)	N/A	N/A	DWS Contrast?	N/A
N/A	Landing Slope (%)	N/A	N/A	DWS Length (in)	N/A
N/A	Landing X Slope (%)	N/A	N/A	DWS Full Width?	N/A
N/A	Landing Curb? (Y/N)	N/A	N/A	DWS Offset (in)	N/A
N/A	Shared Landing?	N/A			
N/A	Gutter Ponding?	N/A	N/A	Gutter Slope (%)	N/A
N/A	Gutter Lip Ht (in)	N/A	N/A	Gutter X Slope (%)	N/A
N/A	Painted X Walk1?	No	N/A	Painted X Walk2?	No
	X Walk 1 Direction	To E		X Walk 2 Direction	To N
N/A	X Walk 1 Width (in)	N/A	N/A	X Walk 2 Width (in)	N/A
	X Walk 1 Slope (%)	3.4		X Walk 2 Slope (%)	4.3
	X Walk 1 X Slope (%)	4.5		X Walk 2 X Slope (%)	3.4

N/A	Ramp inside XWalk1?	N/A	N/A	Ramp inside XWalk2?	N/A
	Road Slope (%)	3.7	N/A	Clear Space?	N/A
	Road X Slope (%)	3.9	N/A	Clear Space to XWalk (in)	N/A
N/A	Any Obstructions?	N/A	N/A	Storm Grate/Utility Hazard?	N/A
	Obstruction Type			Storm Grate/Utility Type	
		N/A			N/A
			Yes	Surface Condition? (G/P)	Good

**Remove & Replace Curb Ramp With Two New Directional Ramps or Equivalent.**

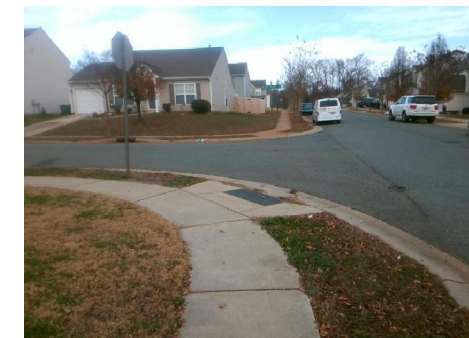
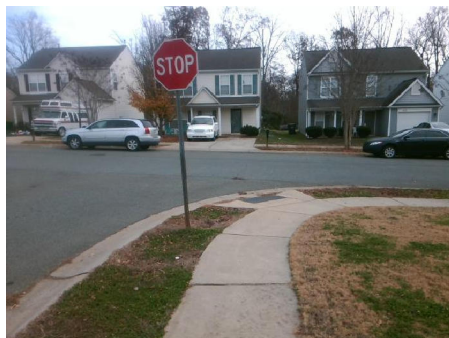
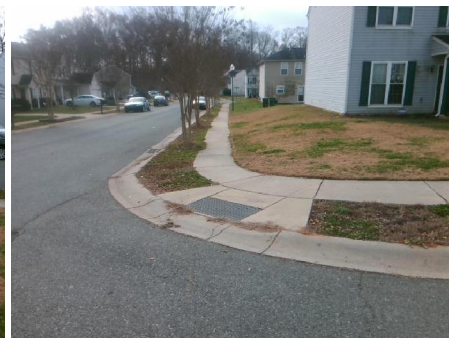
Street 1 Name **ROCKWOOD RD**  
 Stop Condition-Street 2 **None**  
 Street 2 Name **PEACH PLACE LN**  
 Stop Condition-Street 1 **StopSign**
