# Access Compliance Report

## Public Rights-of-Way

### (Curb Ramps)

Intersection ID: 12830	Main Street: CARYA_POND_LN	Cross Street: HICKORY_GROVE_RD	Location: W
ADA ID: 39B56BEF760B	Ramp Type: Para	Initial Pass/Fail: Fail	Overall Compliance: No
			Severity Score: 13.75

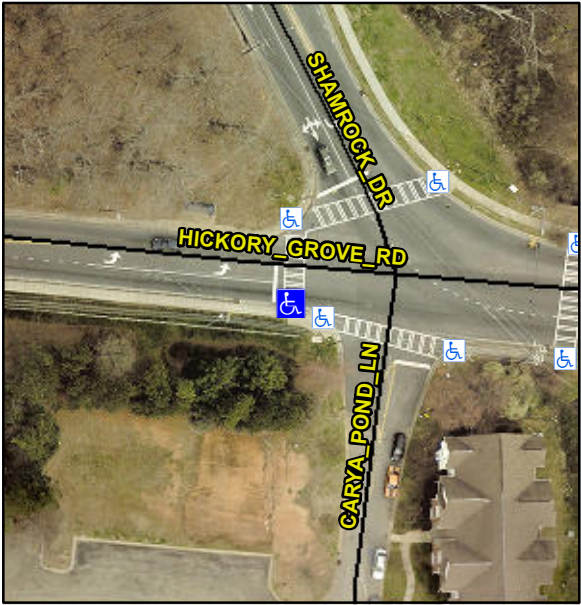
Possible Solutions:		<b>Compliance</b>	<b>Description</b>	<b>Data</b>
	Remove & Replace Entire Ramp.		N/A	Ramp Length LT (in)	69.5
			Yes	Ramp Width LT (in)	59.5
			Yes	Ramp Slope LT (%)	5.9
			No	Ramp XSlope LT (%)	2.4
			N/A	Landing Length (in)	N/A
			N/A	Landing Width (in)	N/A
			N/A	Landing Slope (%)	N/A
			N/A	Landing X Slope (%)	N/A
			N/A	Landing Curb? (Y/N)	N/A
<p>Surveyor Notes:</p> <p>N/A</p> <p>PROW/ADA:</p> <p>R304.5.3, R304.3.2</p>			N/A	Shared Landing?	N/A
			N/A	Gutter Ponding?	N/A
			N/A	Gutter Lip Ht (in)	N/A
			N/A	Painted X Walk1?	No
				X Walk 1 Direction	To N
			N/A	X Walk 1 Width (in)	N/A
				X Walk 1 Slope (%)	4.2
				X Walk 1 X Slope (%)	2.2
			N/A	Ramp inside XWalk1?	N/A
				Road Slope (%)	N/A
<p>Street 1 Name</p> <p>Stop Condition-Street 1</p> <p>Street 2 Name</p> <p>Stop Condition-Street 2</p>			N/A	Road X Slope (%)	N/A

N/A	Any Obstructions?	N/A
				Obstruction Type	
<p>Total Cost:</p> <p>\$ 1600.00</p>			N/A		N/A
			Yes	Surface Condition? (G/P)	Good
			N/A	Curb Slope (%)	12.8
