Access Compliance Report Public Rights-of-Way (Curb Ramps)

Intersection ID: 13057 Main Street: E MOREHEAD ST Cross Street: S COLLEGE ST Location: NW **Overall Compliance: No Severity Score:** ADA ID: 39BE063D50A5 Ramp Type: PerpDiag Initial Pass/Fail: Fail 12.5

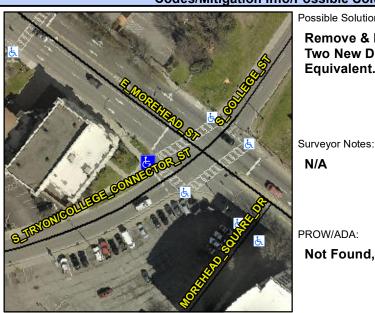
Ramp Slope (%)

Ramp XSlope (%)

Not Found, R304.2.2

Possible Solutions: Remove & Replace Curb Ramp With Two New Directional Ramps or Equivalent.
