# Access Compliance Report

## Public Rights-of-Way

| Intersection ID: N/A | Main Street: SPEER_BV | Cross Street: NATIONAL_AV | Location: SW |
| ADA ID: 39C819EEB9C1 | Ramp Type: MedianPerp | Initial Pass/Fail: Pass | Overall Compliance: No |

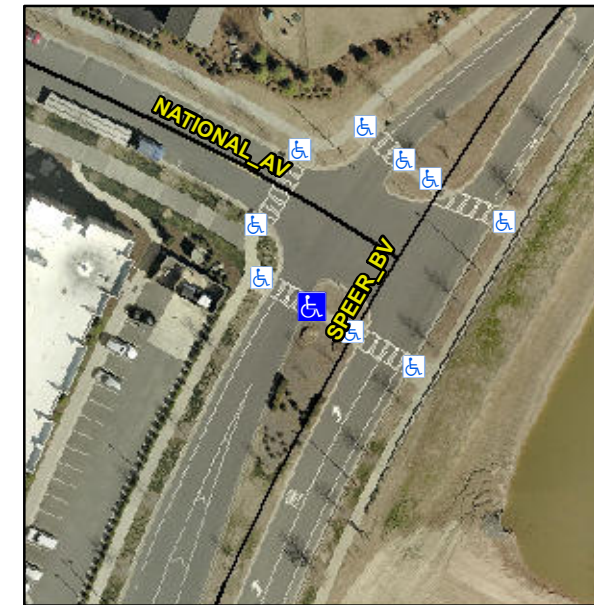
| | | Severity Score: 2.5 | |

| Compliance | Description | Data | Compliance | Description | Data |
|---|---|---|---|---|---|
| N/A | Flare Type LT | Sloped | N/A | Flare Type RT | N/A |
| N/A | Flare Slope LT (%) | 11.0 | Yes | Flare Slope RT (%) | 8.6 |

Possible Solutions:

**Remove & Replace Flare.**

PROW/ADA:

**R304.2.3**

Total Cost: \$ 300.00
