# Access Compliance Report

## Public Rights-of-Way

### (Curb Ramps)

| Intersection ID: 10033082 | | Main Street: NORTH_REA_PARK_LN | | Cross Street: N/A | | Location: SW | | | | | | | | | |

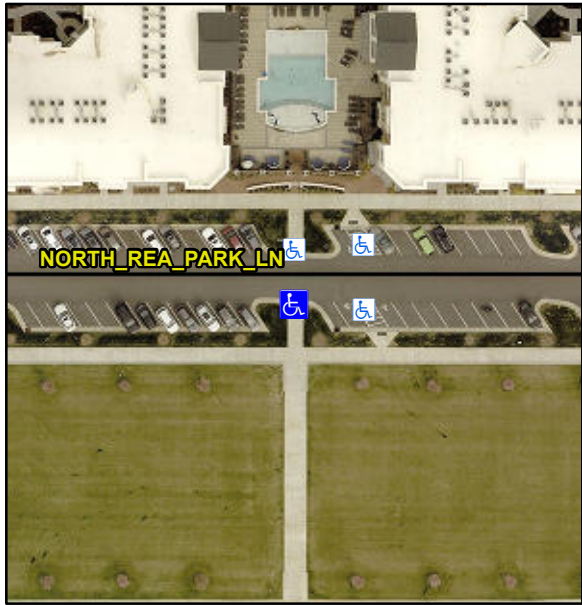
| ADA ID: 39CA4EF1B1F8 | | Ramp Type: Directional1 | | Initial Pass/Fail: Pass | | Overall Compliance: No | | Severity Score: 5 | | | | | | | |
| | | | | Yes | | Ramp Width (in) | | 95.0 | | No | | Grade Break Slope (%) | | 7.8 | |
| Yes | | Gutter Ponding? | | No | | No | | Gutter Slope (%) | | 5.4 | | | | | |

| <div></div> <div>Possible Solutions:<br/><b>Remove &amp; Replace Entire Ramp.</b><br/><b>Remove &amp; Replace Gutter.</b></div> <div>Surveyor Notes:<br/><b>N/A</b></div> <div>PROW/ADA:<br/><b>R304.5.3, R304.5.4</b></div> | | | | Compliance | | Description | | Data | | Compliance | | Description | | Data | |
