# Access Compliance Report

## Public Rights-of-Way

| Intersection ID: 23815 | Main Street: CARMEL_RD | Cross Street: MONTIBELLO_DR | Location: SE |
| ADA ID: 39D5CEB973E4 | Ramp Type: PerpDiag | Initial Pass/Fail: Fail | Overall Compliance: No |

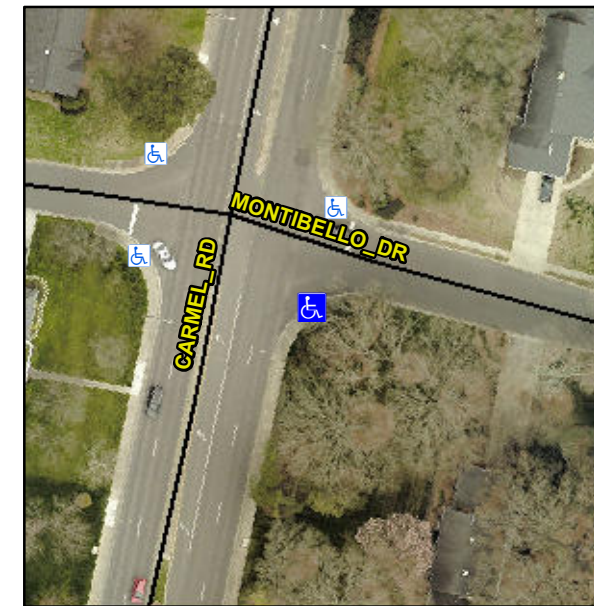
| | | Severity Score: 22.5 | |

**R304.5.1, R304.2.2, R304.5.3**

| Compliance | Description | Data | Compliance | Description | Data |
|---|---|---|---|---|---|
| N/A | Ramp Length (in) | 61.0 | No | Ramp Slope (%) | 9.6 |
| No | Ramp Width (in) | 44.0 | No | Ramp XSlope (%) | 3.0 |

**Remove & Replace Curb Ramp With Two New Directional Ramps or Equivalent.**

Total Cost: \$ 3200.00
