Access Compliance Report

Public Rights-of-Way

(Curb Ramps)

Intersection ID: 53744	Main Street: SMITH_RD	Cross Street: CANTERBURY_CASTLE_DR	Location: NW
ADA ID: 39DD5CC21A8A	Ramp Type: BlendTrans1	Initial Pass/Fail: Fail	Overall Compliance: No
Severity Score: 8.75			
Codes/Mitigation Info/Possible Solution		Field Measurements/Component Compliance

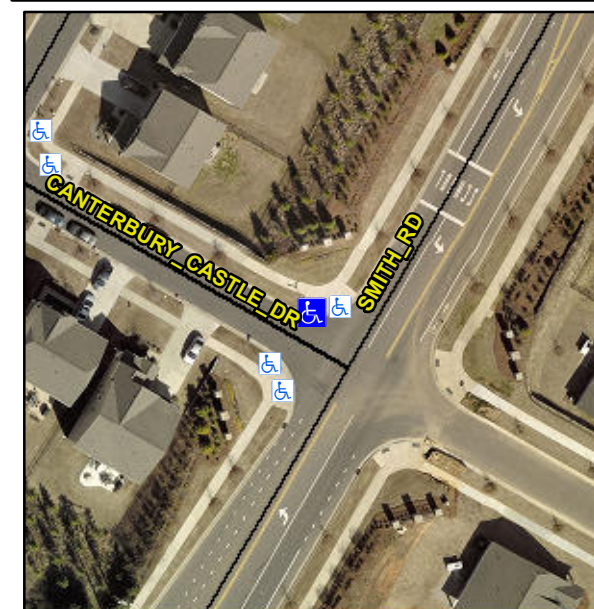
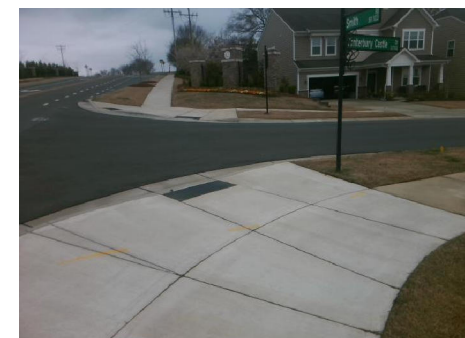
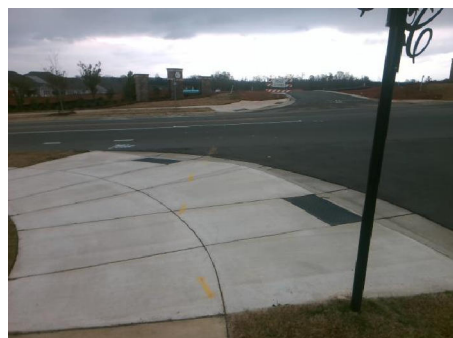
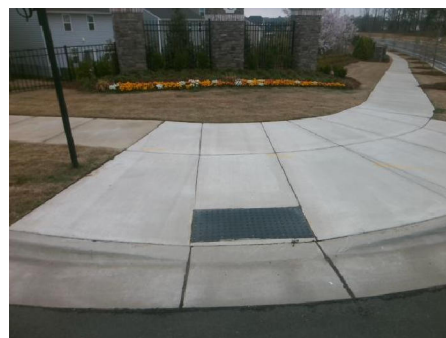
Not Found, R304.5.1

Compliance	Description	Data	Compliance	Description	Data
N/A	Ramp Length (in)	95.0	Yes	BlendTrans Slope (%)	0.7
No	Ramp Width (in)	46.5	Yes	BlendTrans XSlope (%)	1.1
N/A	Flare Type LT	N/A	N/A	Flare Type RT	N/A
N/A	Flare Slope LT (%)	N/A	N/A	Flare Slope RT (%)	N/A
N/A	Flare Traversable LT?	N/A	N/A	Flare Traversable RT?	N/A
N/A	Landing Length (in)	N/A	N/A	DWS Provided?	N/A
N/A	Landing Width (in)	N/A	N/A	DWS Contrast?	N/A
N/A	Landing Slope (%)	N/A	N/A	DWS Length (in)	N/A
N/A	Landing X Slope (%)	N/A	N/A	DWS Full Width?	N/A
N/A	Landing Curb? (Y/N)	N/A	N/A	DWS Offset (in)	N/A
N/A	Shared Landing?	N/A			
N/A	Gutter Ponding?	N/A	N/A	Gutter Slope (%)	N/A
N/A	Gutter Lip Ht (in)	N/A	N/A	Gutter X Slope (%)	N/A
N/A	Painted X Walk1?	No	N/A	Painted X Walk2?	N/A
	X Walk 1 Direction	To SW		X Walk 2 Direction	N/A
	X Walk 1 Width (in)	N/A		X Walk 2 Width (in)	N/A
	X Walk 1 Slope (%)	6.9		X Walk 2 Slope (%)	N/A
	X Walk 1 X Slope (%)	2.5		X Walk 2 X Slope (%)	N/A

N/A	Ramp inside XWalk1?	N/A	N/A	Ramp inside XWalk2?	N/A
	Road Slope (%)	2.5		Clear Space?	N/A
	Road X Slope (%)	6.9	N/A	Clear Space to XWalk (in)	N/A
N/A	Any Obstructions?	N/A	N/A	Storm Grate/Utility Hazard?	N/A
	Obstruction Type			Storm Grate/Utility Type	
		N/A			N/A
			Yes	Surface Condition? (G/P)	Good
			No	Curb Slope (%)	6.0

Remove & Replace Curb Ramp With Two New Directional Ramps or Equivalent.
