Access Compliance Report

Public Rights-of-Way

(Curb Ramps)

Intersection ID: 30551	Main Street: EDENDERRY_DR	Cross Street: WEDDINGTON_RD	Location: NW
ADA ID: 39EEDEA2110A	Ramp Type: Perp	Initial Pass/Fail: Fail	Overall Compliance: No
Severity Score: 8.75			
Codes/Mitigation Info/Possible Solution		Field Measurements/Component Compliance

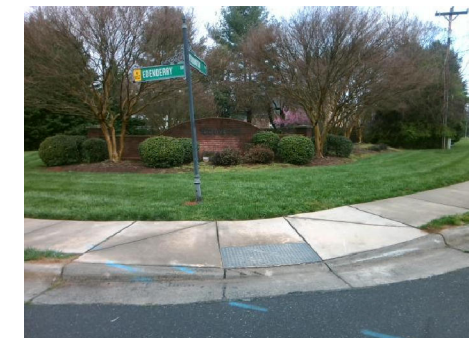
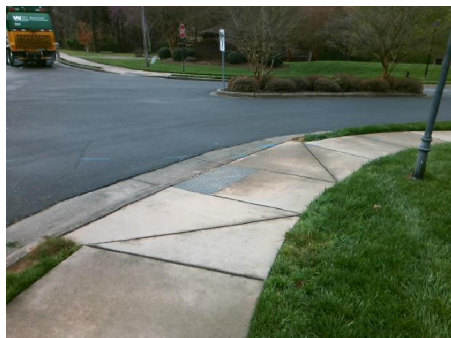
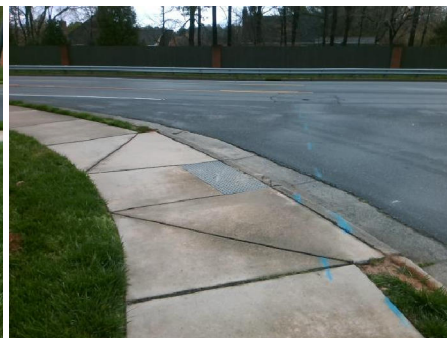
Not Found, R304.5.1

Compliance	Description	Data	Compliance	Description	Data
N/A	Ramp Length (in)	72.0	Yes	Ramp Slope (%)	6.4
No	Ramp Width (in)	45.5	Yes	Ramp XSlope (%)	0.6
N/A	Flare Type LT	N/A	N/A	Flare Type RT	N/A
N/A	Flare Slope LT (%)	N/A	N/A	Flare Slope RT (%)	N/A
N/A	Flare Traversable LT?	N/A	N/A	Flare Traversable RT?	N/A
N/A	Landing Length (in)	N/A	N/A	DWS Provided?	N/A
N/A	Landing Width (in)	N/A	N/A	DWS Contrast?	N/A
N/A	Landing Slope (%)	N/A	N/A	DWS Length (in)	N/A
N/A	Landing X Slope (%)	N/A	N/A	DWS Full Width?	N/A
N/A	Landing Curb? (Y/N)	N/A	N/A	DWS Offset (in)	N/A
N/A	Shared Landing?	N/A			
N/A	Gutter Ponding?	N/A	N/A	Gutter Slope (%)	N/A
N/A	Gutter Lip Ht (in)	N/A	N/A	Gutter X Slope (%)	N/A
N/A	Painted X Walk1?	No	N/A	Painted X Walk2?	N/A
	X Walk 1 Direction	To S		X Walk 2 Direction	N/A
N/A	X Walk 1 Width (in)	N/A	N/A	X Walk 2 Width (in)	N/A
	X Walk 1 Slope (%)	2.9		X Walk 2 Slope (%)	N/A
	X Walk 1 X Slope (%)	3.1		X Walk 2 X Slope (%)	N/A

N/A	Ramp inside XWalk1?	N/A	N/A	Ramp inside XWalk2?	N/A
	Road Slope (%)	N/A	N/A	Clear Space?	N/A
	Road X Slope (%)	N/A	N/A	Clear Space to XWalk (in)	N/A
N/A	Any Obstructions?	N/A	N/A	Storm Grate/Utility Hazard?	N/A
	Obstruction Type			Storm Grate/Utility Type	
		N/A			N/A
			Yes	Surface Condition? (G/P)	Good

Remove & Replace Entire Ramp.
