Access Compliance Report

Public Rights-of-Way

(Curb Ramps)

Intersection ID: 10038266	Main Street: SMITHFIELD_CHURCH_RD	Cross Street: N/A	Location: S
ADA ID: 3A0497A29A89	Ramp Type: Perp	Initial Pass/Fail: Fail	Overall Compliance: No
Codes/Mitigation Info/Possible Solution		Field Measurements/Component Compliance	
Severity Score: 12.5

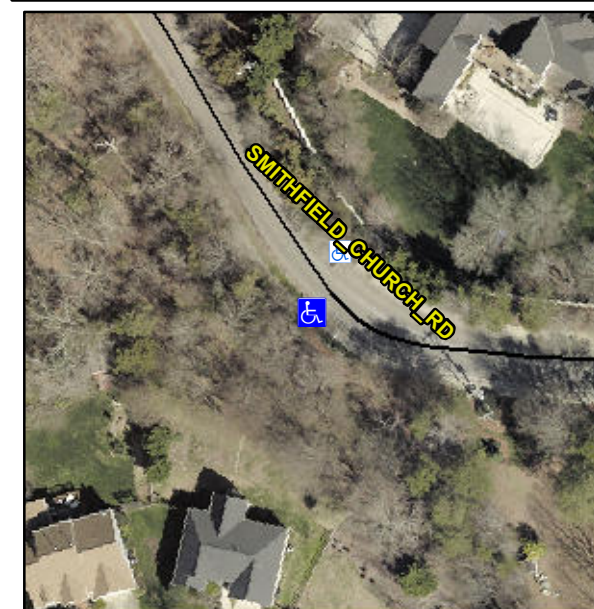
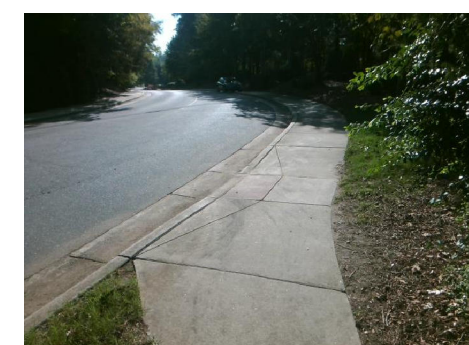
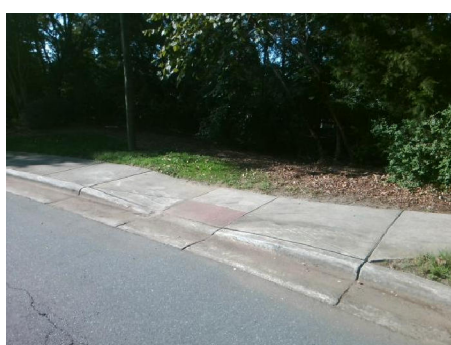
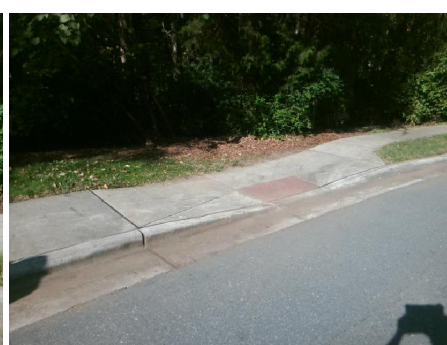
Not Found, R304.2.2

Compliance	Description	Data	Compliance	Description	Data
N/A	Ramp Length (in)	60.0	No	Ramp Slope (%)	8.9
Yes	Ramp Width (in)	48.0	Yes	Ramp XSlope (%)	2.0
N/A	Flare Type LT	N/A	N/A	Flare Type RT	N/A
N/A	Flare Slope LT (%)	N/A	N/A	Flare Slope RT (%)	N/A
N/A	Flare Traversable LT?	N/A	N/A	Flare Traversable RT?	N/A
N/A	Landing Length (in)	N/A	N/A	DWS Provided?	N/A
N/A	Landing Width (in)	N/A	N/A	DWS Contrast?	N/A
N/A	Landing Slope (%)	N/A	N/A	DWS Length (in)	N/A
N/A	Landing X Slope (%)	N/A	N/A	DWS Full Width?	N/A
N/A	Landing Curb? (Y/N)	N/A	N/A	DWS Offset (in)	N/A
N/A	Shared Landing?	N/A			
N/A	Gutter Ponding?	N/A	N/A	Gutter Slope (%)	N/A
N/A	Gutter Lip Ht (in)	N/A	N/A	Gutter X Slope (%)	N/A
N/A	Painted X Walk1?	No	N/A	Painted X Walk2?	N/A
	X Walk 1 Direction	To N		X Walk 2 Direction	N/A
N/A	X Walk 1 Width (in)	N/A	N/A	X Walk 2 Width (in)	N/A
	X Walk 1 Slope (%)	2.3		X Walk 2 Slope (%)	N/A
	X Walk 1 X Slope (%)	0.4		X Walk 2 X Slope (%)	N/A

N/A	Ramp inside XWalk1?	N/A	N/A	Ramp inside XWalk2?	N/A
	Road Slope (%)	N/A	N/A	Clear Space?	N/A
	Road X Slope (%)	N/A	N/A	Clear Space to XWalk (in)	N/A
N/A	Any Obstructions?	N/A	N/A	Storm Grate/Utility Hazard?	N/A
	Obstruction Type			Storm Grate/Utility Type	
		N/A			N/A
			Yes	Surface Condition? (G/P)	Good

Possible Solutions:

Remove & Replace Entire Ramp.

Total Cost: \$ 1850.00
