# Access Compliance Report

## Public Rights-of-Way

### (Curb Ramps)

| Intersection ID: N/A | | Main Street: N COLLEGE ST | | Cross Street: E 7TH ST | | Location: N | | | |

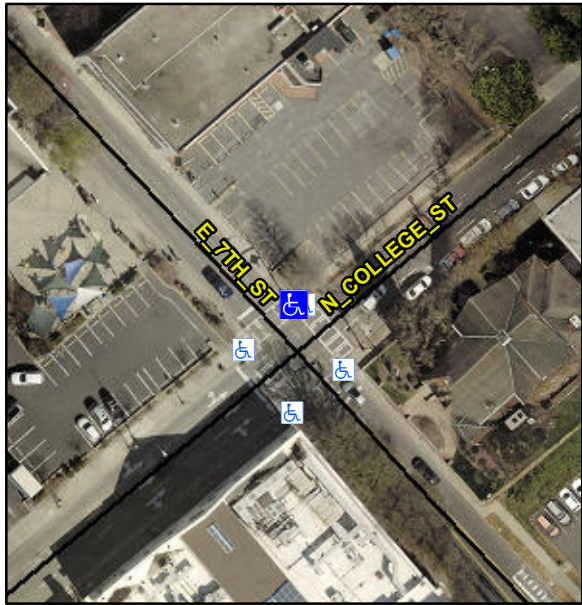
| <div></div> <div>Possible Solutions:<br/><b>Remove &amp; Replace Entire Ramp.</b></div> <div>Surveyor Notes:<br/><b>N/A</b></div> <div>PROW/ADA:<br/><b>R304.5.3</b></div> <div>Street 1 Name<br/><b>E 7TH ST</b></div> <div>Stop Condition-Street 1<br/><b>Signal</b></div> <div>Street 2 Name<br/><b>N/A</b></div> <div>Stop Condition-Street 2<br/><b>N/A</b></div> <div>Total Cost: \$ <b>1800.00</b></div> | | | | Compliance | Description | Data | Compliance | Description | Data |
| | | | | Yes | Ramp Width (in) | 60.0 | N/A | Grade Break Slope (%) | 0.0 |
| | | | | Yes | Ramp Slope (%) | 7.9 | N/A | Grade Break XSlope (%) | 0.0 |
| | | | | No | Ramp XSlope (%) | 12.7 | | | |
