Access Compliance Report

Public Rights-of-Way

(Curb Ramps)

Intersection ID: 7486	Main Street: N_TRYON_ST	Cross Street: OWEN_BV	Location: SE
ADA ID: 3A1C2A0DBFFD	Ramp Type: Perp	Initial Pass/Fail: Fail	Overall Compliance: No
Severity Score: 21.25			
Codes/Mitigation Info/Possible Solution		Field Measurements/Component Compliance

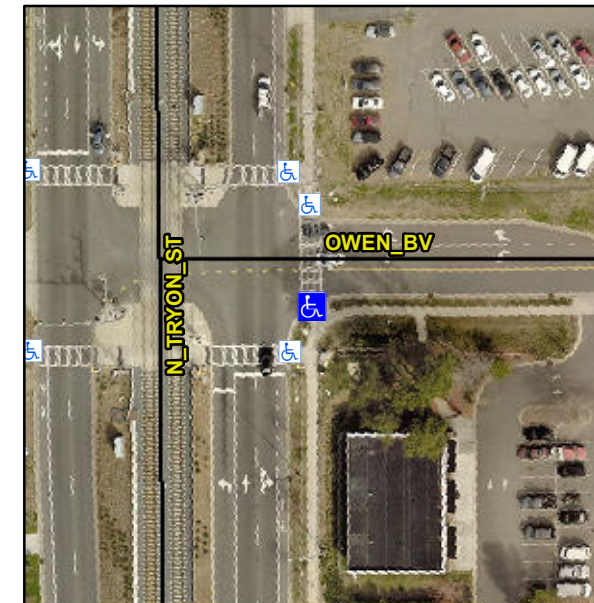
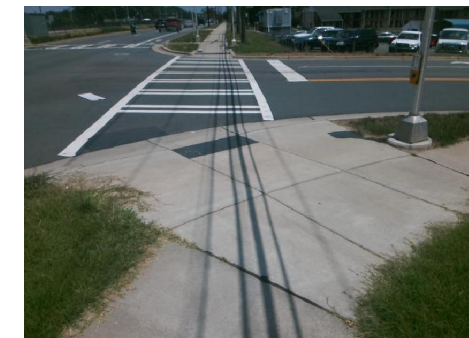
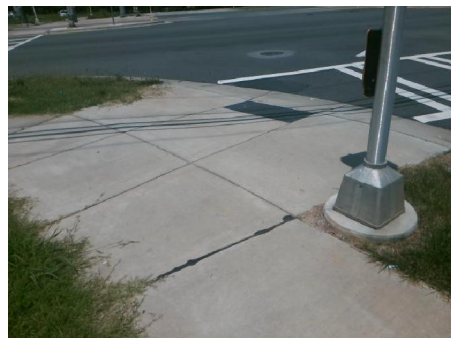
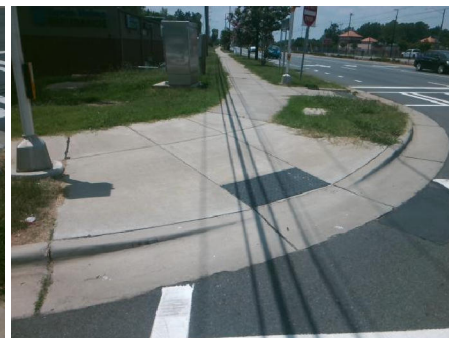
R304.5.1, R304.5.3

Compliance	Description	Data	Compliance	Description	Data
N/A	Ramp Length (in)	91.0	Yes	Ramp Slope (%)	7.3
No	Ramp Width (in)	46.5	No	Ramp XSlope (%)	5.8
N/A	Flare Type LT	N/A	N/A	Flare Type RT	N/A
N/A	Flare Slope LT (%)	N/A	N/A	Flare Slope RT (%)	N/A
N/A	Flare Traversable LT?	N/A	N/A	Flare Traversable RT?	N/A
N/A	Landing Length (in)	N/A	N/A	DWS Provided?	N/A
N/A	Landing Width (in)	N/A	N/A	DWS Contrast?	N/A
N/A	Landing Slope (%)	N/A	N/A	DWS Length (in)	N/A
N/A	Landing X Slope (%)	N/A	N/A	DWS Full Width?	N/A
N/A	Landing Curb? (Y/N)	N/A	N/A	DWS Offset (in)	N/A
N/A	Shared Landing?	N/A			
N/A	Gutter Ponding?	N/A	N/A	Gutter Slope (%)	N/A
N/A	Gutter Lip Ht (in)	N/A	N/A	Gutter X Slope (%)	N/A
N/A	Painted X Walk1?	Yes	N/A	Painted X Walk2?	N/A
	X Walk 1 Direction	To N		X Walk 2 Direction	N/A
N/A	X Walk 1 Width (in)	117.0	N/A	X Walk 2 Width (in)	N/A
	X Walk 1 Slope (%)	1.9		X Walk 2 Slope (%)	N/A
	X Walk 1 X Slope (%)	4.7		X Walk 2 X Slope (%)	N/A

N/A	Ramp inside XWalk1?	Yes	N/A	Ramp inside XWalk2?	N/A
	Road Slope (%)	N/A	N/A	Clear Space?	N/A
	Road X Slope (%)	N/A	N/A	Clear Space to XWalk (in)	N/A
N/A	Any Obstructions?	N/A	N/A	Storm Grate/Utility Hazard?	N/A
	Obstruction Type			Storm Grate/Utility Type	
		N/A			N/A
		Yes		Surface Condition? (G/P)	Good

Remove & Replace Entire Ramp.
