# Access Compliance Report

## Public Rights-of-Way

### (Curb Ramps)

Intersection ID: 19579	Main Street: ROXBOROUGH PARKWAY_DRCross Street: ROXBOROUGH_RD	Location:	N
ADA ID: 3A2195906A59	Ramp Type: PerpDiag	Initial Pass/Fail: Fail	Overall Compliance: No
		Severity Score:	37.5
Codes/Mitigation Info/Possible Solution		Field Measurements/Component Compliance

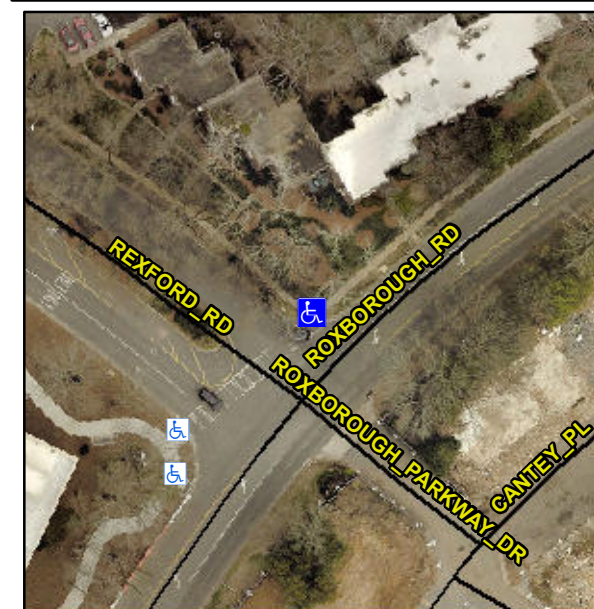
**Not Found, R304.2.2, R304.5.3**

Compliance	Description	Data	Compliance	Description	Data
N/A	Ramp Length (in)	65.0	No	Ramp Slope (%)	12.1
Yes	Ramp Width (in)	48.0	No	Ramp XSlope (%)	5.2
N/A	Flare Type LT	N/A	N/A	Flare Type RT	N/A
N/A	Flare Slope LT (%)	N/A	N/A	Flare Slope RT (%)	N/A
N/A	Flare Traversable LT?	N/A	N/A	Flare Traversable RT?	N/A
N/A	Landing Length (in)	N/A	N/A	DWS Provided?	N/A
N/A	Landing Width (in)	N/A	N/A	DWS Contrast?	N/A
N/A	Landing Slope (%)	N/A	N/A	DWS Length (in)	N/A
N/A	Landing X Slope (%)	N/A	N/A	DWS Full Width?	N/A
N/A	Landing Curb? (Y/N)	N/A	N/A	DWS Offset (in)	N/A
N/A	Shared Landing?	N/A			
N/A	Gutter Ponding?	N/A	N/A	Gutter Slope (%)	N/A
N/A	Gutter Lip Ht (in)	N/A	N/A	Gutter X Slope (%)	N/A
N/A	Painted X Walk1?	Yes	N/A	Painted X Walk2?	No
	X Walk 1 Direction	To SW		X Walk 2 Direction	To SE
N/A	X Walk 1 Width (in)	111.0	N/A	X Walk 2 Width (in)	N/A
	X Walk 1 Slope (%)	1.5		X Walk 2 Slope (%)	4.0
	X Walk 1 X Slope (%)	4.8		X Walk 2 X Slope (%)	0.9

N/A	Ramp inside XWalk1?	Yes	N/A	Ramp inside XWalk2?	N/A
	Road Slope (%)	5.0	N/A	Clear Space?	N/A
	Road X Slope (%)	1.5	N/A	Clear Space to XWalk (in)	N/A
N/A	Any Obstructions?	N/A	N/A	Storm Grate/Utility Hazard?	N/A
	Obstruction Type			Storm Grate/Utility Type	
		N/A			N/A
		Yes		Surface Condition? (G/P)	Good

**Remove & Replace Curb Ramp With Two New Directional Ramps or Equivalent.**
