Access Compliance Report

Public Rights-of-Way

(Curb Ramps)

Intersection ID: 10040204	Main Street: TYVOLA_RD	Cross Street: N/A	Location: NW
ADA ID: 3A2E3DABE102	Ramp Type: PerpDiag	Initial Pass/Fail: Fail	Overall Compliance: No
			Severity Score: 35

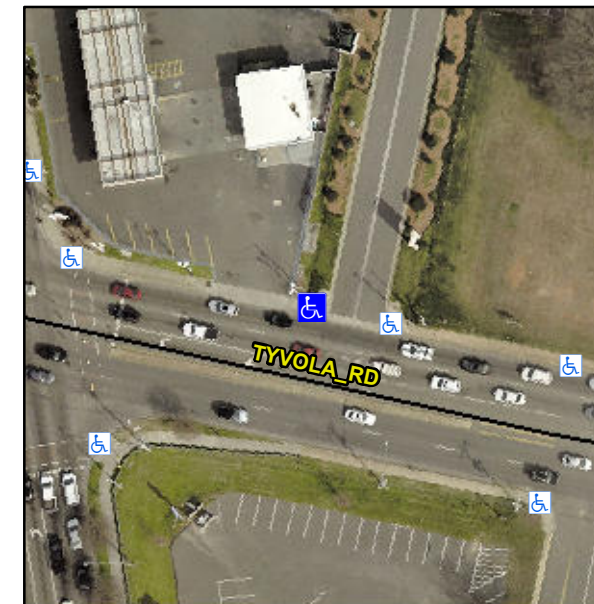
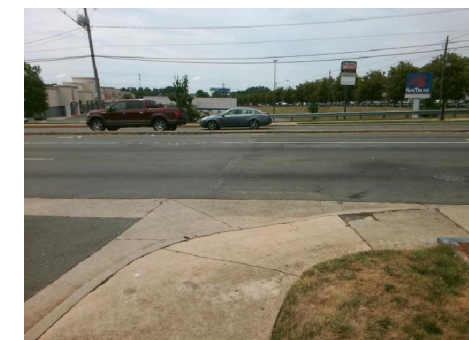
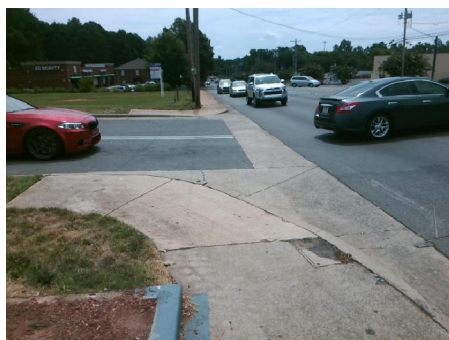
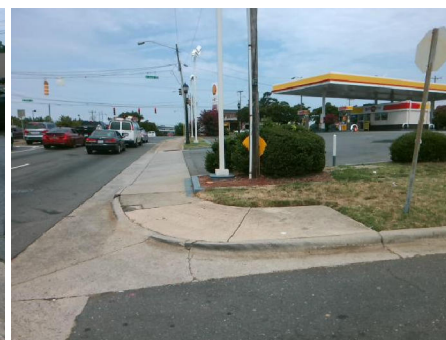
Not Found, R304.5.1, R304.2.2, R304.5.3

Compliance	Description	Data	Compliance	Description	Data
N/A	Ramp Length (in)	63.0	No	Ramp Slope (%)	14.3
No	Ramp Width (in)	45.0	No	Ramp XSlope (%)	2.9
N/A	Flare Type LT	N/A	N/A	Flare Type RT	N/A
N/A	Flare Slope LT (%)	N/A	N/A	Flare Slope RT (%)	N/A
N/A	Flare Traversable LT?	N/A	N/A	Flare Traversable RT?	N/A
N/A	Landing Length (in)	N/A	N/A	DWS Provided?	N/A
N/A	Landing Width (in)	N/A	N/A	DWS Contrast?	N/A
N/A	Landing Slope (%)	N/A	N/A	DWS Length (in)	N/A
N/A	Landing X Slope (%)	N/A	N/A	DWS Full Width?	N/A
N/A	Landing Curb? (Y/N)	N/A	N/A	DWS Offset (in)	N/A
N/A	Shared Landing?	N/A			
N/A	Gutter Ponding?	N/A	N/A	Gutter Slope (%)	N/A
N/A	Gutter Lip Ht (in)	2.0	N/A	Gutter X Slope (%)	N/A
N/A	Painted X Walk1?	No	N/A	Painted X Walk2?	No
	X Walk 1 Direction	To S		X Walk 2 Direction	To S
N/A	X Walk 1 Width (in)	N/A	N/A	X Walk 2 Width (in)	N/A
	X Walk 1 Slope (%)	4.9		X Walk 2 Slope (%)	2.1
	X Walk 1 X Slope (%)	3.7		X Walk 2 X Slope (%)	2.4

N/A	Ramp inside XWalk1?	N/A	N/A	Ramp inside XWalk2?	N/A
	Road Slope (%)	1.7	N/A	Clear Space?	N/A
	Road X Slope (%)	1.4	N/A	Clear Space to XWalk (in)	N/A
N/A	Any Obstructions?	N/A	N/A	Storm Grate/Utility Hazard?	N/A
	Obstruction Type			Storm Grate/Utility Type	
		N/A			N/A
			Yes	Surface Condition? (G/P)	Good

Remove & Replace Curb Ramp With Two New Directional Ramps or Equivalent.
