Access Compliance Report

Public Rights-of-Way

(Curb Ramps)

Intersection ID: 7848	Main Street: KENDALL_DR	Cross Street: SENIOR_DR	Location: NE
ADA ID: 3A3471F69C16	Ramp Type: Perp	Initial Pass/Fail: Fail	Overall Compliance: No
		Severity Score: 25

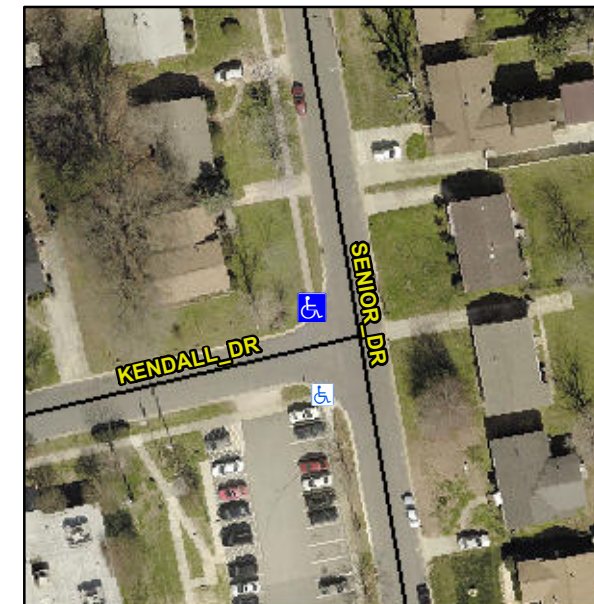
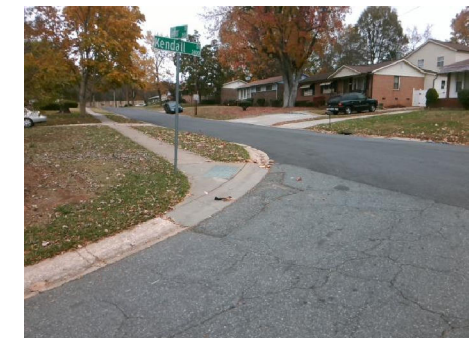
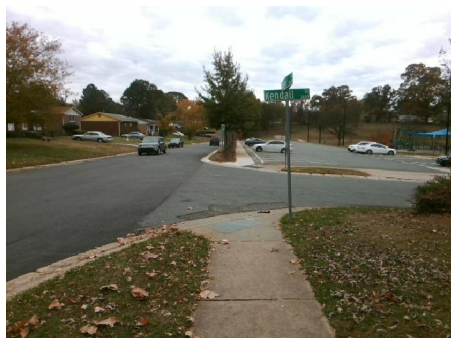
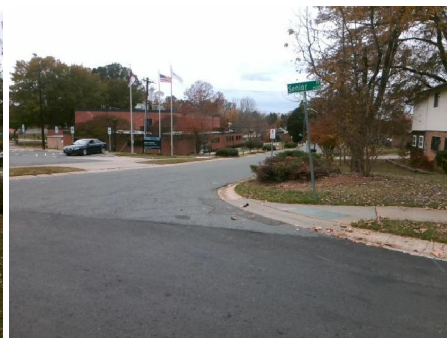
Not Found, R304.5.3

Compliance	Description	Data	Compliance	Description	Data
N/A	Ramp Length (in)	42.0	Yes	Ramp Slope (%)	5.7
Yes	Ramp Width (in)	48.0	No	Ramp XSlope (%)	8.0
N/A	Flare Type LT	N/A	N/A	Flare Type RT	N/A
N/A	Flare Slope LT (%)	N/A	N/A	Flare Slope RT (%)	N/A
N/A	Flare Traversable LT?	N/A	N/A	Flare Traversable RT?	N/A
N/A	Landing Length (in)	N/A	N/A	DWS Provided?	N/A
N/A	Landing Width (in)	N/A	N/A	DWS Contrast?	N/A
N/A	Landing Slope (%)	N/A	N/A	DWS Length (in)	N/A
N/A	Landing X Slope (%)	N/A	N/A	DWS Full Width?	N/A
N/A	Landing Curb? (Y/N)	N/A	N/A	DWS Offset (in)	N/A
N/A	Shared Landing?	N/A			
N/A	Gutter Ponding?	N/A	N/A	Gutter Slope (%)	N/A
N/A	Gutter Lip Ht (in)	N/A	N/A	Gutter X Slope (%)	N/A
N/A	Painted X Walk1?	No	N/A	Painted X Walk2?	N/A
	X Walk 1 Direction	To S		X Walk 2 Direction	N/A
N/A	X Walk 1 Width (in)	N/A	N/A	X Walk 2 Width (in)	N/A
	X Walk 1 Slope (%)	1.9		X Walk 2 Slope (%)	N/A
	X Walk 1 X Slope (%)	6.0		X Walk 2 X Slope (%)	N/A

Remove & Replace Entire Ramp.

Total Cost: \$ 1850.00
