Access Compliance Report

Public Rights-of-Way

(Curb Ramps)

Intersection ID: 30312	Main Street: BLACK_KETTLE_DR	Cross Street: OLD_CONCORD_RD	Location:	N
ADA ID: 3A3BFBAB7791	Ramp Type: Perp	Initial Pass/Fail: Fail	Overall Compliance: No	Severity Score: 10
Codes/Mitigation Info/Possible Solution		Field Measurements/Component Compliance

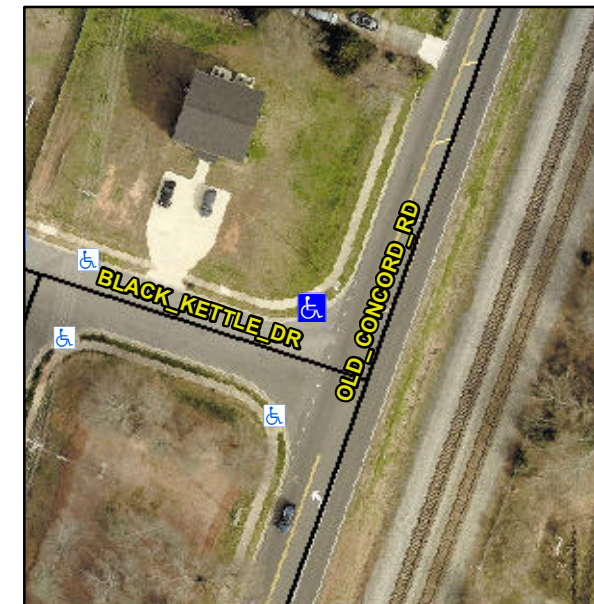
Compliance	Description	Data	Compliance	Description	Data
N/A	Ramp Length (in)	59.0	Yes	Ramp Slope (%)	6.9
No	Ramp Width (in)	44.0	No	Ramp XSlope (%)	2.1
N/A	Flare Type LT	N/A	N/A	Flare Type RT	N/A
N/A	Flare Slope LT (%)	N/A	N/A	Flare Slope RT (%)	N/A
N/A	Flare Traversable LT?	N/A	N/A	Flare Traversable RT?	N/A
N/A	Landing Length (in)	N/A	N/A	DWS Provided?	N/A
N/A	Landing Width (in)	N/A	N/A	DWS Contrast?	N/A
N/A	Landing Slope (%)	N/A	N/A	DWS Length (in)	N/A
N/A	Landing X Slope (%)	N/A	N/A	DWS Full Width?	N/A
N/A	Landing Curb? (Y/N)	N/A	N/A	DWS Offset (in)	N/A
N/A	Shared Landing?	N/A			
N/A	Gutter Ponding?	N/A	N/A	Gutter Slope (%)	N/A
N/A	Gutter Lip Ht (in)	0.5	N/A	Gutter X Slope (%)	N/A
N/A	Painted X Walk1?	No	N/A	Painted X Walk2?	N/A
	X Walk 1 Direction	To SW		X Walk 2 Direction	N/A
N/A	X Walk 1 Width (in)	N/A	N/A	X Walk 2 Width (in)	N/A
	X Walk 1 Slope (%)	0.7		X Walk 2 Slope (%)	N/A
	X Walk 1 X Slope (%)	3.0		X Walk 2 X Slope (%)	N/A

N/A	Ramp inside XWalk1?	N/A	N/A	Ramp inside XWalk2?	N/A
	Road Slope (%)	N/A	N/A	Clear Space?	N/A
	Road X Slope (%)	N/A	N/A	Clear Space to XWalk (in)	N/A
N/A	Any Obstructions?	N/A	N/A	Storm Grate/Utility Hazard?	N/A
	Obstruction Type			Storm Grate/Utility Type	
		N/A			N/A
		Yes		Surface Condition? (G/P)	Good

Possible Solutions:

Remove & Replace Entire Ramp.

PROW/ADA:

R304.5.1, R304.5.3
