Access Compliance Report

Public Rights-of-Way

(Curb Ramps)

Intersection ID: 53339	Main Street: NORTHLAKE CENTRE PY	Cross Street: CALHOUN ST	Location:	W
ADA ID: 3A3D4859022B	Ramp Type: BlendTrans1	Initial Pass/Fail: Fail	Overall Compliance: No	Severity Score: 8.75
Codes/Mitigation Info/Possible Solution		Field Measurements/Component Compliance

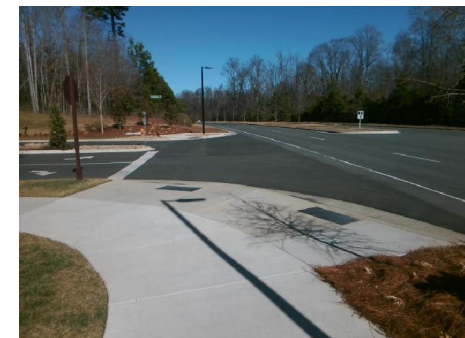
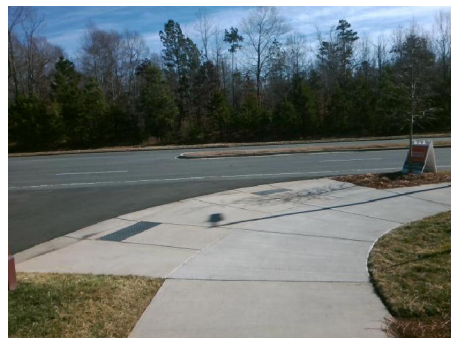
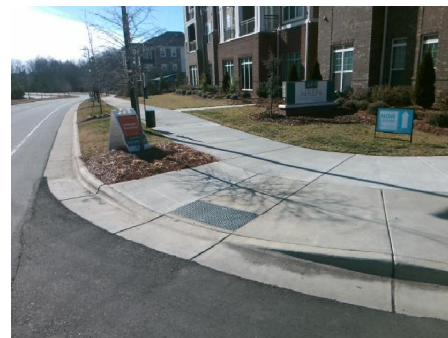
MEDIAN ACROSS NORTHLAKE CENTRE PY

Compliance	Description	Data	Compliance	Description	Data
N/A	Ramp Length (in)	95.0	Yes	BlendTrans Slope (%)	0.9
No	Ramp Width (in)	44.0	Yes	BlendTrans XSlope (%)	1.4
N/A	Flare Type LT	N/A	N/A	Flare Type RT	N/A
N/A	Flare Slope LT (%)	N/A	N/A	Flare Slope RT (%)	N/A
N/A	Flare Traversable LT?	N/A	N/A	Flare Traversable RT?	N/A
N/A	Landing Length (in)	N/A	N/A	DWS Provided?	N/A
N/A	Landing Width (in)	N/A	N/A	DWS Contrast?	N/A
N/A	Landing Slope (%)	N/A	N/A	DWS Length (in)	N/A
N/A	Landing X Slope (%)	N/A	N/A	DWS Full Width?	N/A
N/A	Landing Curb? (Y/N)	N/A	N/A	DWS Offset (in)	N/A
N/A	Shared Landing?	N/A			
N/A	Gutter Ponding?	N/A	N/A	Gutter Slope (%)	N/A
N/A	Gutter Lip Ht (in)	N/A	N/A	Gutter X Slope (%)	N/A
N/A	Painted X Walk1?	No	N/A	Painted X Walk2?	N/A
	X Walk 1 Direction	To SE		X Walk 2 Direction	N/A
	X Walk 1 Width (in)	N/A		X Walk 2 Width (in)	N/A
	X Walk 1 Slope (%)	3.9		X Walk 2 Slope (%)	N/A
	X Walk 1 X Slope (%)	1.2		X Walk 2 X Slope (%)	N/A

N/A	Ramp inside XWalk1?	N/A	N/A	Ramp inside XWalk2?	N/A
	Road Slope (%)	1.2		Clear Space?	N/A
	Road X Slope (%)	3.9	N/A	Clear Space to XWalk (in)	N/A
N/A	Any Obstructions?	N/A	N/A	Storm Grate/Utility Hazard?	N/A
	Obstruction Type			Storm Grate/Utility Type	
		N/A			N/A
			Yes	Surface Condition? (G/P)	Good
			N/A	Curb Slope (%)	1.8

Possible Solutions:

Remove & Replace Curb Ramp With Two New Directional Ramps or Equivalent.

R304.5.1
