# Access Compliance Report

## Public Rights-of-Way

### (Curb Ramps)

Intersection ID: 29761	Main Street: KING_ARTHUR_DR	Cross Street: LOURDES_CT	Location: SW
ADA ID: 3A470ACE511B	Ramp Type: PerpDiag	Initial Pass/Fail: Fail	Overall Compliance: No
Severity Score: 21.25			
Codes/Mitigation Info/Possible Solution		Field Measurements/Component Compliance

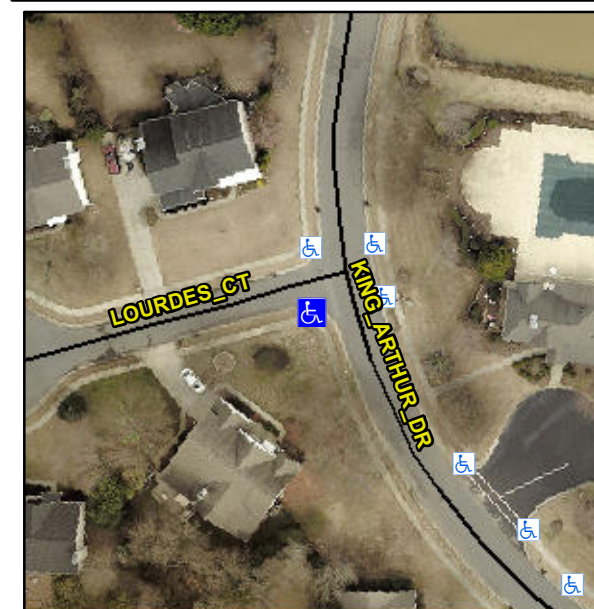
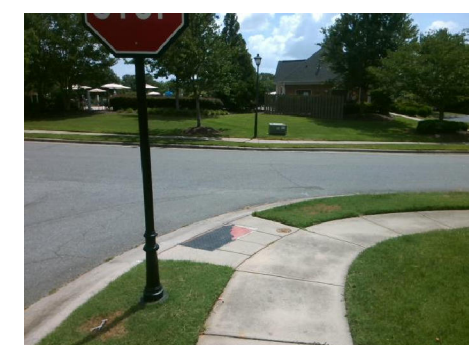
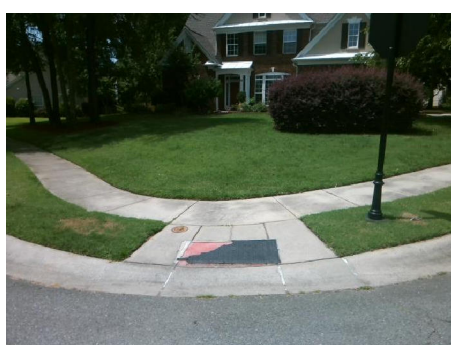
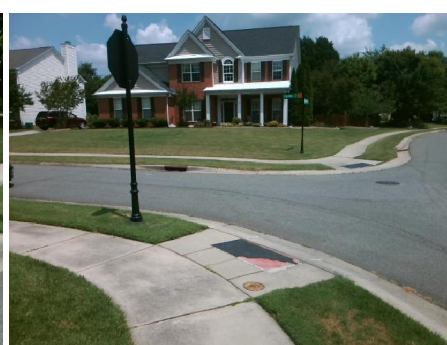
**Not Found, R304.5.1, R304.5.3**

Compliance	Description	Data	Compliance	Description	Data
N/A	Ramp Length (in)	48.0	Yes	Ramp Slope (%)	6.7
No	Ramp Width (in)	38.0	No	Ramp XSlope (%)	5.9
N/A	Flare Type LT	N/A	N/A	Flare Type RT	N/A
N/A	Flare Slope LT (%)	N/A	N/A	Flare Slope RT (%)	N/A
N/A	Flare Traversable LT?	N/A	N/A	Flare Traversable RT?	N/A
N/A	Landing Length (in)	N/A	N/A	DWS Provided?	N/A
N/A	Landing Width (in)	N/A	N/A	DWS Contrast?	N/A
N/A	Landing Slope (%)	N/A	N/A	DWS Length (in)	N/A
N/A	Landing X Slope (%)	N/A	N/A	DWS Full Width?	N/A
N/A	Landing Curb? (Y/N)	N/A	N/A	DWS Offset (in)	N/A
N/A	Shared Landing?	N/A			
N/A	Gutter Ponding?	N/A	N/A	Gutter Slope (%)	N/A
N/A	Gutter Lip Ht (in)	N/A	N/A	Gutter X Slope (%)	N/A
N/A	Painted X Walk1?	No	N/A	Painted X Walk2?	No
	X Walk 1 Direction	To E		X Walk 2 Direction	To N
N/A	X Walk 1 Width (in)	N/A	N/A	X Walk 2 Width (in)	N/A
	X Walk 1 Slope (%)	0.5		X Walk 2 Slope (%)	2.2
	X Walk 1 X Slope (%)	2.8		X Walk 2 X Slope (%)	1.6

N/A	Ramp inside XWalk1?	N/A	N/A	Ramp inside XWalk2?	N/A
	Road Slope (%)	3.7	N/A	Clear Space?	N/A
	Road X Slope (%)	3.3	N/A	Clear Space to XWalk (in)	N/A
N/A	Any Obstructions?	N/A	N/A	Storm Grate/Utility Hazard?	N/A
	Obstruction Type			Storm Grate/Utility Type	
		N/A			N/A
		Yes		Surface Condition? (G/P)	Good

**Remove & Replace Curb Ramp With Two New Directional Ramps or Equivalent.**

Total Cost: \$ 3200.00
