Access Compliance Report

Public Rights-of-Way

(Curb Ramps)

Intersection ID: 5384	Main Street: LONG_CREEK_PY	Cross Street: WILLOW_CREST_DR	Location: S
ADA ID: 3A4D5DE2BD89	Ramp Type: Perp	Initial Pass/Fail: Fail	Overall Compliance: No
			Severity Score: 33.75

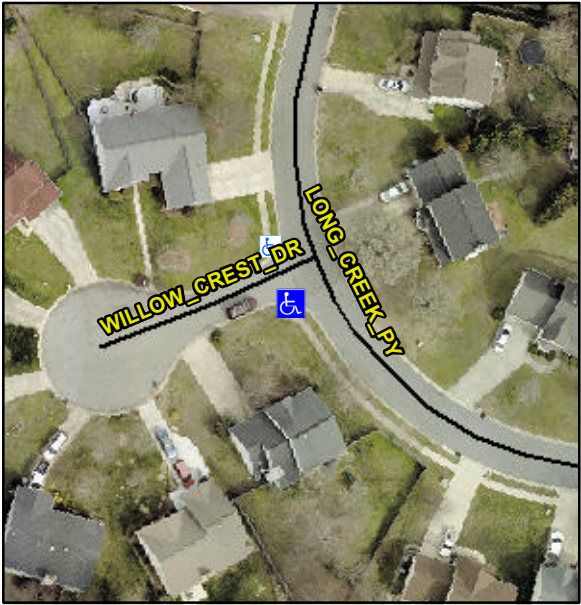
Possible Solutions:		Compliance	Description	Data
	Remove & Replace Entire Ramp.		N/A	Ramp Length (in)	46.0
			No	Ramp Width (in)	44.0
			N/A	Flare Type LT	N/A
			N/A	Flare Slope LT (%)	N/A
			N/A	Flare Traversable LT?	N/A
			N/A	Landing Length (in)	N/A
			N/A	Landing Width (in)	N/A
			N/A	Landing Slope (%)	N/A
			N/A	Landing X Slope (%)	N/A
<p>Surveyor Notes:</p> <p>N/A</p> <p>PROW/ADA:</p> <p>R304.5.1, R304.2.2, R304.5.3</p>			N/A	Flare Type RT	N/A
			N/A	Flare Slope RT (%)	N/A
			N/A	Flare Traversable RT?	N/A
			N/A	DWS Provided?	N/A
			N/A	DWS Contrast?	N/A
			N/A	DWS Length (in)	N/A
			N/A	DWS Full Width?	N/A
			N/A	DWS Offset (in)	N/A
			N/A	Shared Landing?	N/A
			N/A	Gutter Ponding?	N/A
			N/A	Gutter Lip Ht (in)	0.5
			N/A	Painted X Walk1?	No
				X Walk 1 Direction	To N
			N/A	X Walk 1 Width (in)	N/A
				X Walk 1 Slope (%)	0.1

X Walk 1 X Slope (%)	5.3
			N/A	Ramp inside XWalk1?	N/A
				Road Slope (%)	N/A
				Road X Slope (%)	N/A
			N/A	Any Obstructions?	N/A
				Obstruction Type	
Total Cost:		\$ 1850.00			
			N/A		N/A
			Yes	Surface Condition? (G/P)	Good
