Access Compliance Report

Public Rights-of-Way

(Curb Ramps)

Intersection ID: 27584	Main Street: ELM_LN	Cross Street: WILLIAMS_POND_LN	Location: NE
ADA ID: 3A5EDCF3CECC	Ramp Type: Perp	Initial Pass/Fail: Fail	Overall Compliance: No
Severity Score: 10			
Codes/Mitigation Info/Possible Solution		Field Measurements/Component Compliance

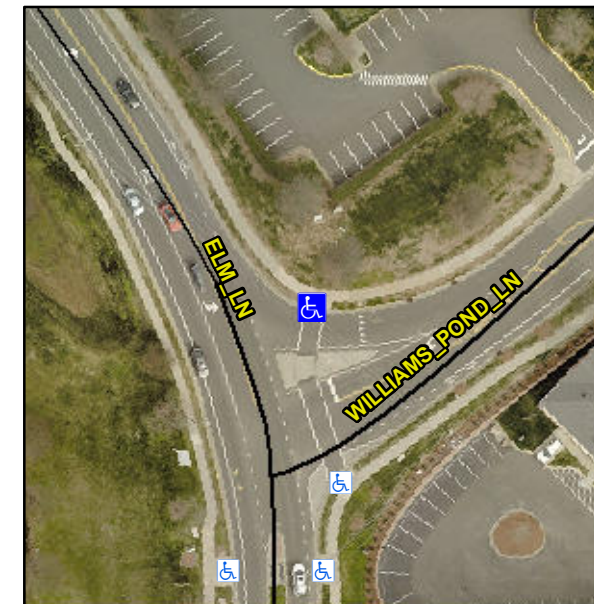
Not Found, R304.5.1, R304.5.3

Compliance	Description	Data	Compliance	Description	Data
N/A	Ramp Length (in)	56.0	Yes	Ramp Slope (%)	7.6
No	Ramp Width (in)	44.0	No	Ramp XSlope (%)	4.4
N/A	Flare Type LT	N/A	N/A	Flare Type RT	N/A
N/A	Flare Slope LT (%)	N/A	N/A	Flare Slope RT (%)	N/A
N/A	Flare Traversable LT?	N/A	N/A	Flare Traversable RT?	N/A
N/A	Landing Length (in)	N/A	N/A	DWS Provided?	N/A
N/A	Landing Width (in)	N/A	N/A	DWS Contrast?	N/A
N/A	Landing Slope (%)	N/A	N/A	DWS Length (in)	N/A
N/A	Landing X Slope (%)	N/A	N/A	DWS Full Width?	N/A
N/A	Landing Curb? (Y/N)	N/A	N/A	DWS Offset (in)	N/A
N/A	Shared Landing?	N/A			
N/A	Gutter Ponding?	N/A	N/A	Gutter Slope (%)	N/A
N/A	Gutter Lip Ht (in)	N/A	N/A	Gutter X Slope (%)	N/A
N/A	Painted X Walk1?	Yes	N/A	Painted X Walk2?	N/A
	X Walk 1 Direction	To SW		X Walk 2 Direction	N/A
N/A	X Walk 1 Width (in)	129.0	N/A	X Walk 2 Width (in)	N/A
	X Walk 1 Slope (%)	0.8		X Walk 2 Slope (%)	N/A
	X Walk 1 X Slope (%)	6.8		X Walk 2 X Slope (%)	N/A

N/A	Ramp inside XWalk1?	Yes	N/A	Ramp inside XWalk2?	N/A
	Road Slope (%)	N/A	N/A	Clear Space?	N/A
	Road X Slope (%)	N/A	N/A	Clear Space to XWalk (in)	N/A
N/A	Any Obstructions?	N/A	N/A	Storm Grate/Utility Hazard?	N/A
	Obstruction Type			Storm Grate/Utility Type	
		N/A			N/A
		Yes		Surface Condition? (G/P)	Good

Possible Solutions:

Remove & Replace Entire Ramp.
