Access Compliance Report Public Rights-of-Way (Curb Ramps)

Intersection ID: 13384 Main Street: S_MINT_ST Cross Street: W_PARK_AV								Location:	NE
ADA ID: 3A5EF289DE2D Ramp Type: PerpDiag			Initial	Initial Pass/Fail: Fail Overall Compliance: No				o Severity Score:	13.75
Codes/Mitigation Info/Possible Solution				Field Measurements/Component Compliance					
		Possible Solutions:		Compliance Description			Data Compliance Description		Data
		Remove & Replace Curb Ramp	With	N/A	Ramp Length (in)	46.0	No	Ramp Slope (%)	9.5
		Two New Directional Ramps or	•	Yes	Ramp Width (in)	67.0	No	Ramp XSlope (%)	3.5
		Equivalent.		N/A	Flare Type LT	N/A	N/A	Flare Type RT	N/A
				N/A	Flare Slope LT (%)	N/A	N/A	Flare Slope RT (%)	N/A
				N/A	Flare Traversable LT?	N/A	N/A	Flare Traversable RT?	N/A
				N/A	Landing Length (in)	N/A	N/A	DWS Provided?	N/A
		Surveyor Notes:		N/A	Landing Width (in)	N/A	N/A	DWS Contrast?	N/A
		N/A		N/A	Landing Slope (%)	N/A	N/A	DWS Length (in)	N/A
				N/A	Landing X Slope (%)	N/A	N/A	DWS Full Width?	N/A

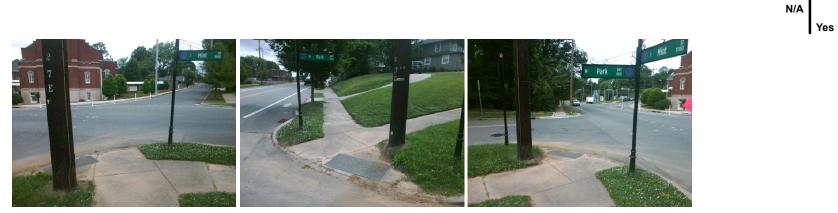
L. L.		Not Found, R304.2.2, R304.5.3		N/A	Gutter Lip Ht (in)	N/A	N/A	Gutter X Slope (%)	N/A
		, ,		N/A	Painted X Walk1?	No	N/A	Painted X Walk2?	No
	Para.				X Walk 1 Direction	To NW		X Walk 2 Direction	To NE
				N/A	X Walk 1 Width (in)	N/A	N/A	X Walk 2 Width (in)	N/A
Street 1 Name	S MINT ST				X Walk 1 Slope (%)	6.0		X Walk 2 Slope (%)	1.4
Stop Condition-Street 2	None				X Walk 1 X Slope (%)	0.1		X Walk 2 X Slope (%)	0.5
Street 2 Name	W PARK AV			N/A	Ramp inside XWalk1?	N/A	N/A	Ramp inside XWalk2?	N/A
Stop Condition-Street 1	StopSign				Road Slope (%)	4.2	N/A	Clear Space?	N/A
					Road X Slope (%)	3.8	N/A	Clear Space to XWalk (in)	N/A
				N/A	Any Obstructions?	N/A	N/A	Storm Grate/Utility Hazard?	N/A
		Total Cost: \$	3200.00		Obstruction Type			Storm Grate/Utility Type	
						N/A			N/A
