Access Compliance Report

Public Rights-of-Way

(Curb Ramps)

Intersection ID: N/A	Main Street: PARK_RD	Cross Street: N/A	Location: NW
ADA ID: 3A64AC815C07	Ramp Type: Directional2	Initial Pass/Fail: Fail	Overall Compliance: No
		Severity Score: 12.5

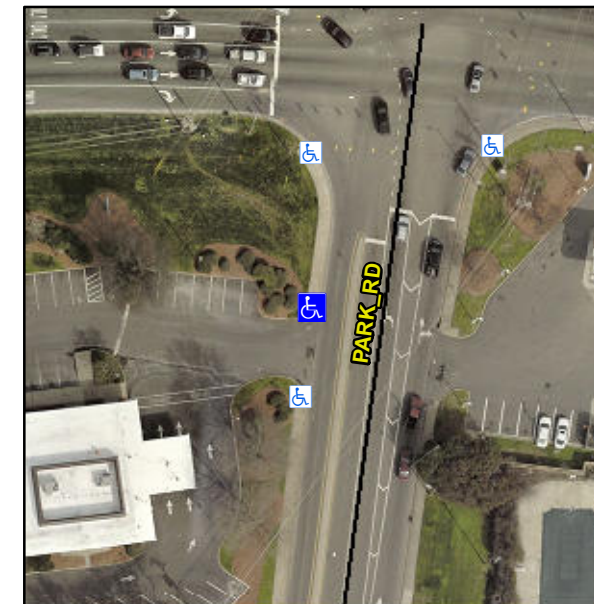
Compliance	Description	Data	Compliance	Description	Data
N/A	Ramp Length (in)	86.0	N/A	Grade Break?	N/A
Yes	Ramp Width (in)	48.0	N/A	Grade Break Slope (%)	0.0
Yes	Ramp Slope (%)	6.9	N/A	Grade Break XSlope (%)	0.0
No	Ramp XSlope (%)	5.2			
N/A	Flare Type LT	N/A	N/A	Flare Type RT	N/A
N/A	Flare Slope LT (%)	N/A	N/A	Flare Slope RT (%)	0.0
N/A	Flare Traversable LT?	N/A	N/A	Flare Traversable RT?	N/A
N/A	Landing Length (in)	0.0	N/A	DWS Provided?	N/A
N/A	Landing Width (in)	0.0	N/A	DWS Contrast?	N/A
N/A	Landing Slope (%)	0.0	N/A	DWS Length (in)	N/A
N/A	Landing X Slope (%)	0.0	N/A	DWS Full Width?	N/A
N/A	Landing Curb? (Y/N)	N/A	N/A	DWS Offset LT (in)	N/A
N/A	Shared Landing?	N/A	N/A	DWS Offset RT (in)	N/A
N/A	Gutter Ponding?	0.0	N/A	Gutter Slope (%)	N/A
N/A	Gutter Lip Ht (in)	0.0	N/A	Gutter X Slope (%)	N/A
N/A	Painted X Walk1?	No		Road Slope (%)	0.8
	X Walk 1 Direction	To S		Road X Slope (%)	2.5
	X Walk 1 Width (in)	N/A		Clear Space?	N/A

X Walk 1 Slope (%)	0.8	N/A	Clear Space to XWalk (in)	N/A
	X Walk 1 X Slope (%)	2.5	N/A	Storm Grate/Utility Hazard?	N/A
N/A	Ramp inside XWalk1?	N/A		Storm Grate/Utility Type	
N/A	Any Obstructions?	N/A			N/A
	Obstruction Type		Yes	Surface Condition? (G/P)	Good
			N/A	Curb Slope (%)	0.8

Possible Solutions:

Remove & Replace Entire Ramp.
