# Access Compliance Report

## Public Rights-of-Way

### (Curb Ramps)

Intersection ID: 52996	Main Street: TIMBERBROOK_DR	Cross Street: VICTORIA_BROOK_LN	Location: SW
ADA ID: 3A69D4C05374	Ramp Type: PerpDiag	Initial Pass/Fail: Fail	Overall Compliance: No
Severity Score: 21.25			
Codes/Mitigation Info/Possible Solution		Field Measurements/Component Compliance

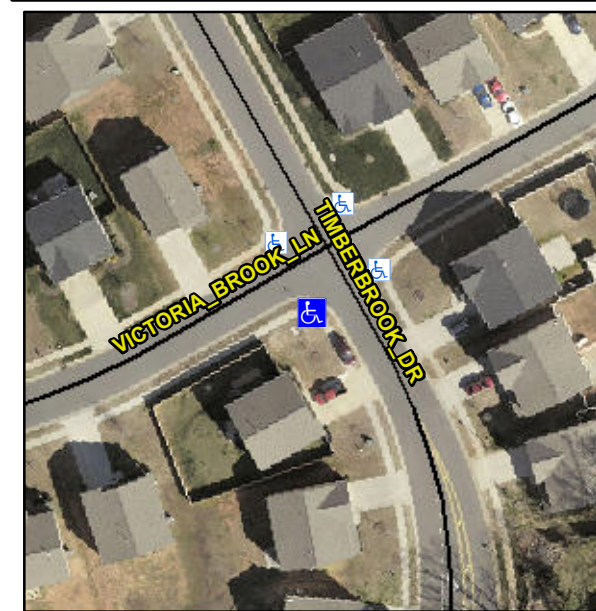
**Not Found, R304.5.1, R304.2.2**

Compliance	Description	Data	Compliance	Description	Data
N/A	Ramp Length (in)	48.0	No	Ramp Slope (%)	9.7
No	Ramp Width (in)	47.0	Yes	Ramp XSlope (%)	1.9
N/A	Flare Type LT	N/A	N/A	Flare Type RT	N/A
N/A	Flare Slope LT (%)	N/A	N/A	Flare Slope RT (%)	N/A
N/A	Flare Traversable LT?	N/A	N/A	Flare Traversable RT?	N/A
N/A	Landing Length (in)	N/A	N/A	DWS Provided?	N/A
N/A	Landing Width (in)	N/A	N/A	DWS Contrast?	N/A
N/A	Landing Slope (%)	N/A	N/A	DWS Length (in)	N/A
N/A	Landing X Slope (%)	N/A	N/A	DWS Full Width?	N/A
N/A	Landing Curb? (Y/N)	N/A	N/A	DWS Offset (in)	N/A
N/A	Shared Landing?	N/A			
N/A	Gutter Ponding?	N/A	N/A	Gutter Slope (%)	N/A
N/A	Gutter Lip Ht (in)	N/A	N/A	Gutter X Slope (%)	N/A
N/A	Painted X Walk1?	No	N/A	Painted X Walk2?	No
	X Walk 1 Direction	To E		X Walk 2 Direction	To N
N/A	X Walk 1 Width (in)	N/A	N/A	X Walk 2 Width (in)	N/A
	X Walk 1 Slope (%)	1.6		X Walk 2 Slope (%)	1.9
	X Walk 1 X Slope (%)	1.2		X Walk 2 X Slope (%)	3.8

N/A	Ramp inside XWalk1?	N/A	N/A	Ramp inside XWalk2?	N/A
	Road Slope (%)	1.9	N/A	Clear Space?	N/A
	Road X Slope (%)	2.5	N/A	Clear Space to XWalk (in)	N/A
N/A	Any Obstructions?	N/A	N/A	Storm Grate/Utility Hazard?	N/A
	Obstruction Type			Storm Grate/Utility Type	
		N/A			N/A
			Yes	Surface Condition? (G/P)	Good

**Remove & Replace Curb Ramp With Two New Directional Ramps or Equivalent.**
