Access Compliance Report

Public Rights-of-Way

(Curb Ramps)

Intersection ID: 13434	Main Street: E_MOREHEAD_ST	Cross Street: S_CALDWELL_ST	Location: E
ADA ID: 3A6FB9684EF9	Ramp Type: PerpDiag	Initial Pass/Fail: Fail	Overall Compliance: No
Severity Score: 12.5			
Codes/Mitigation Info/Possible Solution		Field Measurements/Component Compliance

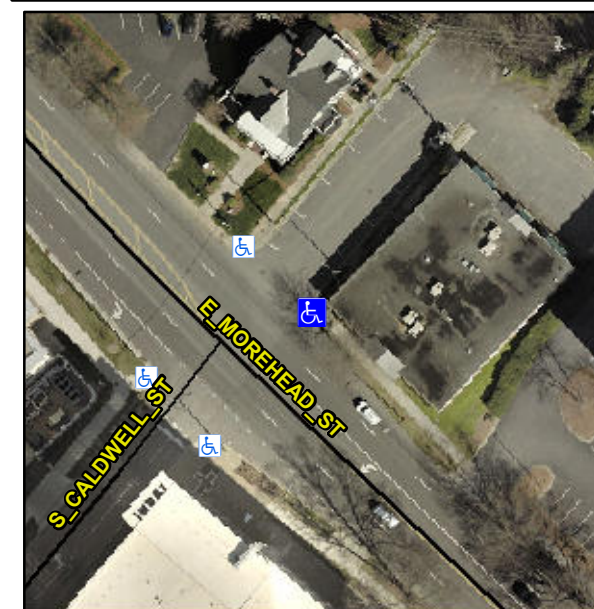
Compliance	Description	Data	Compliance	Description	Data
N/A	Ramp Length (in)	30.0	Yes	Ramp Slope (%)	6.9
Yes	Ramp Width (in)	60.0	No	Ramp XSlope (%)	5.8
N/A	Flare Type LT	N/A	N/A	Flare Type RT	N/A
N/A	Flare Slope LT (%)	N/A	N/A	Flare Slope RT (%)	N/A
N/A	Flare Traversable LT?	N/A	N/A	Flare Traversable RT?	N/A
N/A	Landing Length (in)	N/A	N/A	DWS Provided?	N/A
N/A	Landing Width (in)	N/A	N/A	DWS Contrast?	N/A
N/A	Landing Slope (%)	N/A	N/A	DWS Length (in)	N/A
N/A	Landing X Slope (%)	N/A	N/A	DWS Full Width?	N/A
N/A	Landing Curb? (Y/N)	N/A	N/A	DWS Offset (in)	N/A
N/A	Shared Landing?	N/A			
N/A	Gutter Ponding?	N/A	N/A	Gutter Slope (%)	N/A
N/A	Gutter Lip Ht (in)	N/A	N/A	Gutter X Slope (%)	N/A
N/A	Painted X Walk1?	No	N/A	Painted X Walk2?	No
	X Walk 1 Direction	To NW		X Walk 2 Direction	To SW
N/A	X Walk 1 Width (in)	N/A	N/A	X Walk 2 Width (in)	N/A
	X Walk 1 Slope (%)	4.2		X Walk 2 Slope (%)	5.5
	X Walk 1 X Slope (%)	1.2		X Walk 2 X Slope (%)	4.3

N/A	Ramp inside XWalk1?	N/A	N/A	Ramp inside XWalk2?	N/A
	Road Slope (%)	3.6	N/A	Clear Space?	N/A
	Road X Slope (%)	6.9	N/A	Clear Space to XWalk (in)	N/A
N/A	Any Obstructions?	N/A	N/A	Storm Grate/Utility Hazard?	N/A
	Obstruction Type			Storm Grate/Utility Type	
		N/A			N/A
		Yes		Surface Condition? (G/P)	Good

Possible Solutions:

Remove & Replace Curb Ramp With Two New Directional Ramps or Equivalent.

R304.5.3
