Access Compliance Report

Public Rights-of-Way

(Curb Ramps)

Intersection ID: 51397	Main Street: WINDYRUSH_RD	Cross Street: BANFIELD_PL	Location: E
ADA ID: 3A867F688636	Ramp Type: PerpDiag	Initial Pass/Fail: Fail	Overall Compliance: No
Severity Score: 21.25			
Codes/Mitigation Info/Possible Solution		Field Measurements/Component Compliance

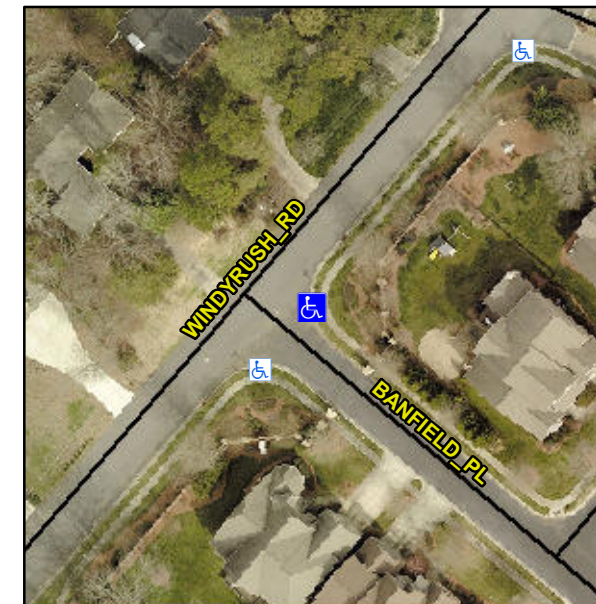
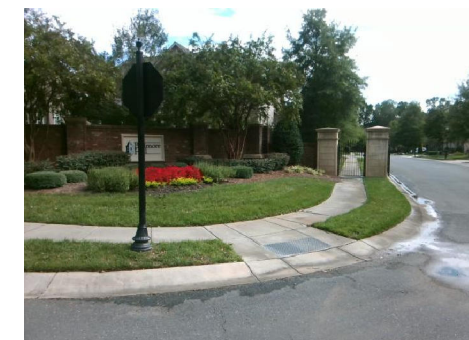
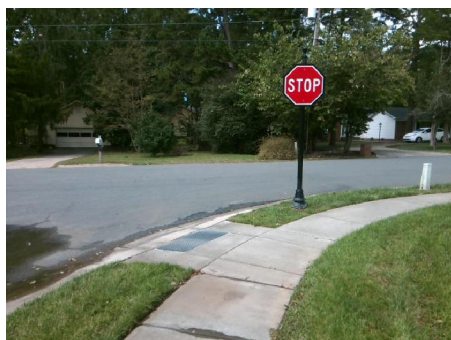
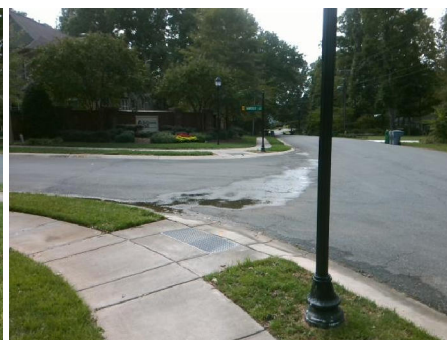
Compliance	Description	Data	Compliance	Description	Data
N/A	Ramp Length (in)	46.0	No	Ramp Slope (%)	8.7
No	Ramp Width (in)	45.0	Yes	Ramp XSlope (%)	0.1
N/A	Flare Type LT	N/A	N/A	Flare Type RT	N/A
N/A	Flare Slope LT (%)	N/A	N/A	Flare Slope RT (%)	N/A
N/A	Flare Traversable LT?	N/A	N/A	Flare Traversable RT?	N/A
N/A	Landing Length (in)	N/A	N/A	DWS Provided?	N/A
N/A	Landing Width (in)	N/A	N/A	DWS Contrast?	N/A
N/A	Landing Slope (%)	N/A	N/A	DWS Length (in)	N/A
N/A	Landing X Slope (%)	N/A	N/A	DWS Full Width?	N/A
N/A	Landing Curb? (Y/N)	N/A	N/A	DWS Offset (in)	N/A
N/A	Shared Landing?	N/A			
N/A	Gutter Ponding?	N/A	N/A	Gutter Slope (%)	N/A
N/A	Gutter Lip Ht (in)	N/A	N/A	Gutter X Slope (%)	N/A
N/A	Painted X Walk1?	No	N/A	Painted X Walk2?	No
	X Walk 1 Direction	To NW		X Walk 2 Direction	To SW
N/A	X Walk 1 Width (in)	N/A	N/A	X Walk 2 Width (in)	N/A
	X Walk 1 Slope (%)	4.1		X Walk 2 Slope (%)	2.8
	X Walk 1 X Slope (%)	1.8		X Walk 2 X Slope (%)	1.9

N/A	Ramp inside XWalk1?	N/A	N/A	Ramp inside XWalk2?	N/A
	Road Slope (%)	2.8	N/A	Clear Space?	N/A
	Road X Slope (%)	1.4	N/A	Clear Space to XWalk (in)	N/A
N/A	Any Obstructions?	N/A	N/A	Storm Grate/Utility Hazard?	N/A
	Obstruction Type			Storm Grate/Utility Type	
		N/A			N/A
		Yes		Surface Condition? (G/P)	Good

Possible Solutions:

Remove & Replace Curb Ramp With Two New Directional Ramps or Equivalent.
