Access Compliance Report Public Rights-of-Way (Curb Ramps)

Intersection ID: 10027202 Main Street: GENTRY_PL Cross Street: N/A Location: S

ADA ID: 3A86C42C5623 Ramp Type: Perp Initial Pass/Fail: Fail Overall Compliance: No Severity Score: 13.75

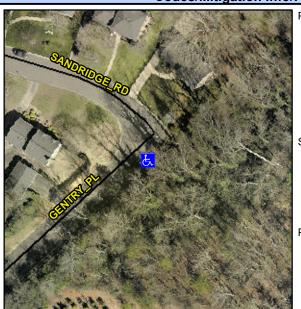
r leid Measurements/Component Compnance							
Comp	liance Description	Data	Comp	liance Description	Data		
N/A	Ramp Length (in)	40.0	No	Ramp Slope (%)	9.9		
Yes	Ramp Width (in)	48.0	No	Ramp XSlope (%)	2.4		
N/A	Flare Type LT	N/A	N/A	Flare Type RT	N/A		
N/A	Flare Slope LT (%)	N/A	N/A	Flare Slope RT (%)	N/A		
N/A	Flare Traversable LT?	N/A	N/A	Flare Traversable RT?	N/A		
N/A	Landing Length (in)	N/A	N/A	DWS Provided?	N/A		
N/A	Landing Width (in)	N/A	N/A	DWS Contrast?	N/A		
N/A	Landing Slope (%)	N/A	N/A	DWS Length (in)	N/A		
N/A	Landing X Slope (%)	N/A	N/A	DWS Full Width?	N/A		
N/A	Landing Curb? (Y/N)	N/A	N/A	DWS Offset (in)	N/A		
N/A	Shared Landing?	N/A					
N/A	Gutter Ponding?	N/A	N/A	Gutter Slope (%)	N/A		
N/A	Gutter Lip Ht (in)	N/A	N/A	Gutter X Slope (%)	N/A		
N/A	Painted X Walk1?	No	N/A	Painted X Walk2?	N/A		
	X Walk 1 Direction	To NW		X Walk 2 Direction	N/A		
N/A	X Walk 1 Width (in)	N/A	N/A	X Walk 2 Width (in)	N/A

X Walk 1 Slope (%)	6.4		X Walk 2 Slope (%)	N/A		
	X Walk 1 X Slope (%)	0.9		X Walk 2 X Slope (%)	N/A		
N/A	Ramp inside XWalk1?	N/A	N/A	Ramp inside XWalk2?	N/A		
	Road Slope (%)	N/A	N/A	Clear Space?	N/A		
	Road X Slope (%)	N/A	N/A	Clear Space to XWalk (in)	N/A		
N/A	Any Obstructions?	N/A	N/A	Storm Grate/Utility Hazard?	N/A		
	Obstruction Type			Storm Grate/Utility Type			
		N/A			N/A

Possible Solution	
Possible Solutions:	<u>c</u>
Remove & Replace Entire Ramp.	N
	Υ
	N
	N
	N
	N
Surveyor Notes:	N
N/A	N
	N
	N
	N
PROW/ADA:	N
R304.2.2, R304.5.3	N
	N
	N
	N
