# Access Compliance Report

## Public Rights-of-Way

### (Curb Ramps)

Intersection ID: 13488	Main Street: E_BLAND_ST	Cross Street: S_COLLEGE_ST	Location: NE
ADA ID: 3A8A38F2C935	Ramp Type: Perp	Initial Pass/Fail: Fail	Overall Compliance: No
			Severity Score: 50

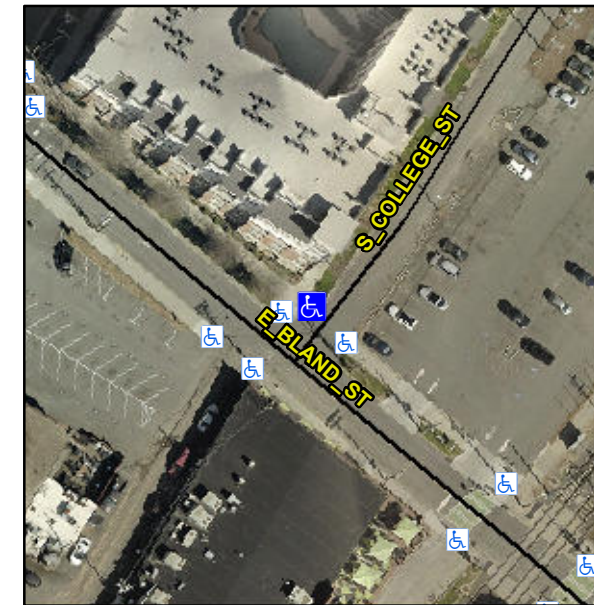
**Not Found, R304.2.2, R304.5.3**

Compliance	Description	Data	Compliance	Description	Data
N/A	Ramp Length (in)	79.0	No	Ramp Slope (%)	12.0
Yes	Ramp Width (in)	48.0	No	Ramp XSlope (%)	14.9
N/A	Flare Type LT	N/A	N/A	Flare Type RT	N/A
N/A	Flare Slope LT (%)	N/A	N/A	Flare Slope RT (%)	N/A
N/A	Flare Traversable LT?	N/A	N/A	Flare Traversable RT?	N/A
N/A	Landing Length (in)	N/A	N/A	DWS Provided?	N/A
N/A	Landing Width (in)	N/A	N/A	DWS Contrast?	N/A
N/A	Landing Slope (%)	N/A	N/A	DWS Length (in)	N/A
N/A	Landing X Slope (%)	N/A	N/A	DWS Full Width?	N/A
N/A	Landing Curb? (Y/N)	N/A	N/A	DWS Offset (in)	N/A
N/A	Shared Landing?	N/A			
N/A	Gutter Ponding?	N/A	N/A	Gutter Slope (%)	N/A
N/A	Gutter Lip Ht (in)	N/A	N/A	Gutter X Slope (%)	N/A
N/A	Painted X Walk1?	No	N/A	Painted X Walk2?	N/A
	X Walk 1 Direction	To SE		X Walk 2 Direction	N/A
N/A	X Walk 1 Width (in)	N/A	N/A	X Walk 2 Width (in)	N/A
	X Walk 1 Slope (%)	3.1		X Walk 2 Slope (%)	N/A
	X Walk 1 X Slope (%)	11.9		X Walk 2 X Slope (%)	N/A

N/A	Ramp inside XWalk1?	N/A	N/A	Ramp inside XWalk2?	N/A
	Road Slope (%)	N/A	N/A	Clear Space?	N/A
	Road X Slope (%)	N/A	N/A	Clear Space to XWalk (in)	N/A
N/A	Any Obstructions?	N/A	N/A	Storm Grate/Utility Hazard?	N/A
	Obstruction Type			Storm Grate/Utility Type	
		N/A			N/A
			Yes	Surface Condition? (G/P)	Good

**Remove & Replace Entire Ramp.**

Total Cost: \$ 1850.00
