Access Compliance Report

Public Rights-of-Way

(Curb Ramps)

Intersection ID: 46787	Main Street: STOWE_ACRES_DR	Cross Street: MALLARD_WOODS_PL	Location: NW
ADA ID: 3A914707A39D	Ramp Type: PerpDiag	Initial Pass/Fail: Fail	Overall Compliance: No
Severity Score: 21.25			
Codes/Mitigation Info/Possible Solution		Field Measurements/Component Compliance

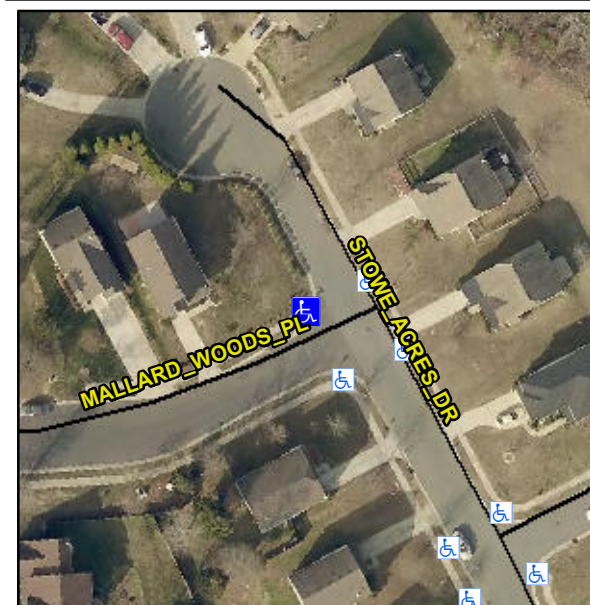
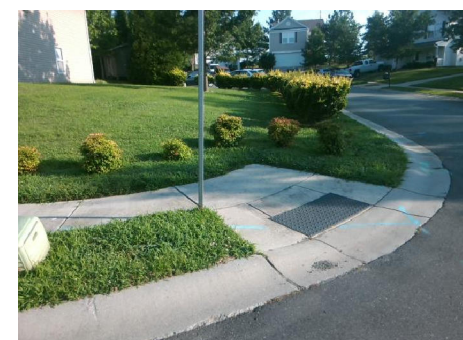
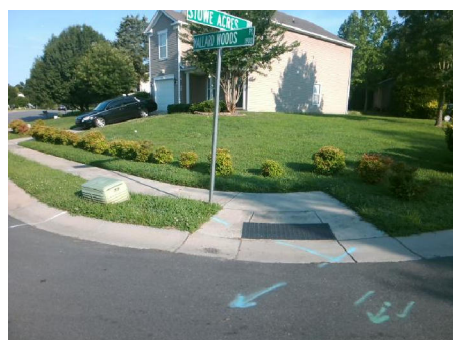
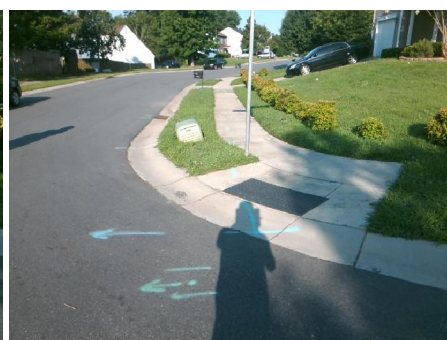
Not Found, R304.5.1, R304.5.3

Compliance	Description	Data	Compliance	Description	Data
N/A	Ramp Length (in)	44.5	Yes	Ramp Slope (%)	5.5
No	Ramp Width (in)	38.0	No	Ramp XSlope (%)	5.2
N/A	Flare Type LT	N/A	N/A	Flare Type RT	N/A
N/A	Flare Slope LT (%)	N/A	N/A	Flare Slope RT (%)	N/A
N/A	Flare Traversable LT?	N/A	N/A	Flare Traversable RT?	N/A
N/A	Landing Length (in)	N/A	N/A	DWS Provided?	N/A
N/A	Landing Width (in)	N/A	N/A	DWS Contrast?	N/A
N/A	Landing Slope (%)	N/A	N/A	DWS Length (in)	N/A
N/A	Landing X Slope (%)	N/A	N/A	DWS Full Width?	N/A
N/A	Landing Curb? (Y/N)	N/A	N/A	DWS Offset (in)	N/A
N/A	Shared Landing?	N/A			
N/A	Gutter Ponding?	N/A	N/A	Gutter Slope (%)	N/A
N/A	Gutter Lip Ht (in)	N/A	N/A	Gutter X Slope (%)	N/A
N/A	Painted X Walk1?	No	N/A	Painted X Walk2?	No
	X Walk 1 Direction	To S		X Walk 2 Direction	To E
N/A	X Walk 1 Width (in)	N/A	N/A	X Walk 2 Width (in)	N/A
	X Walk 1 Slope (%)	0.9		X Walk 2 Slope (%)	4.4
	X Walk 1 X Slope (%)	1.8		X Walk 2 X Slope (%)	2.0

N/A	Ramp inside XWalk1?	N/A	N/A	Ramp inside XWalk2?	N/A
	Road Slope (%)	0.7	N/A	Clear Space?	N/A
	Road X Slope (%)	3.5	N/A	Clear Space to XWalk (in)	N/A
N/A	Any Obstructions?	N/A	N/A	Storm Grate/Utility Hazard?	N/A
	Obstruction Type			Storm Grate/Utility Type	
		N/A			N/A
			Yes	Surface Condition? (G/P)	Good

Possible Solutions:

Remove & Replace Curb Ramp With Two New Directional Ramps or Equivalent.

Total Cost: \$ **3200.00**
