# Access Compliance Report

## Public Rights-of-Way

| Intersection ID: 43354 | Main Street: LAKERIDGE_COMMONS_DR | Cross Street: PROSPERITY_COMMONS_DR | Location: | N |
| ADA ID: 3A9C88149883 | Ramp Type: PerpDiag | Initial Pass/Fail: Fail | Overall Compliance: No | Severity Score: 22.5 |

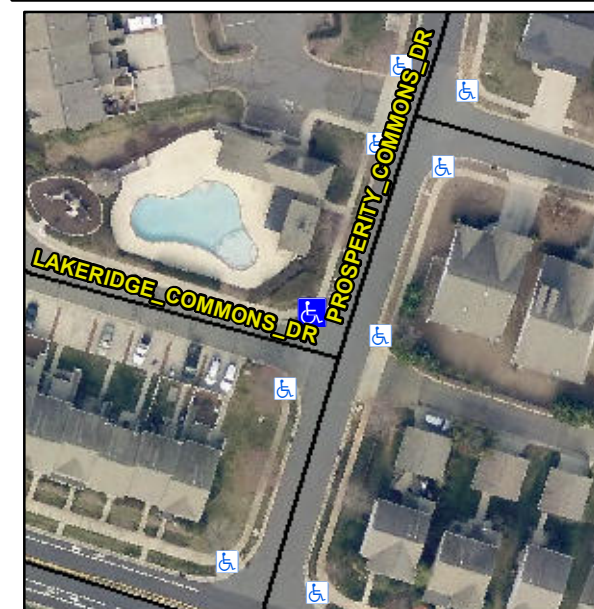
**Not Found, R304.5.1, R304.2.2, R304.5.3**

| Compliance | Description | Data | Compliance | Description | Data |
|---|---|---|---|---|---|
| N/A | Ramp Length (in) | 47.0 | No | Ramp Slope (%) | 11.2 |
| No | Ramp Width (in) | 37.5 | No | Ramp XSlope (%) | 3.2 |

**Remove & Replace Curb Ramp With Two New Directional Ramps or Equivalent.**
