# Access Compliance Report

## Public Rights-of-Way

### (Curb Ramps)

Intersection ID: 48570	Main Street: MATLEA_CT	Cross Street: RED_SQUIRREL_TL	Location: N
ADA ID: 3AA3A883851C	Ramp Type: PerpDiag	Initial Pass/Fail: Fail	Overall Compliance: No
Severity Score: 8.75			
Codes/Mitigation Info/Possible Solution		Field Measurements/Component Compliance

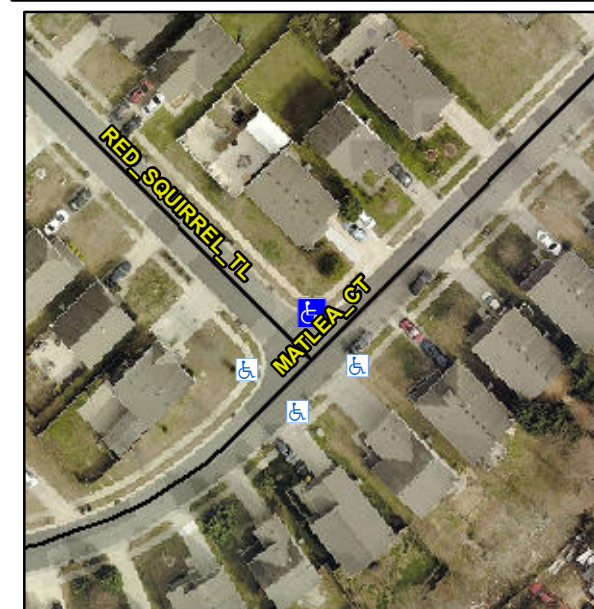
**Not Found, R304.5.1**

Compliance	Description	Data	Compliance	Description	Data
N/A	Ramp Length (in)	45.5	Yes	Ramp Slope (%)	6.2
No	Ramp Width (in)	47.5	Yes	Ramp XSlope (%)	0.1
N/A	Flare Type LT	N/A	N/A	Flare Type RT	N/A
N/A	Flare Slope LT (%)	N/A	N/A	Flare Slope RT (%)	N/A
N/A	Flare Traversable LT?	N/A	N/A	Flare Traversable RT?	N/A
N/A	Landing Length (in)	N/A	N/A	DWS Provided?	N/A
N/A	Landing Width (in)	N/A	N/A	DWS Contrast?	N/A
N/A	Landing Slope (%)	N/A	N/A	DWS Length (in)	N/A
N/A	Landing X Slope (%)	N/A	N/A	DWS Full Width?	N/A
N/A	Landing Curb? (Y/N)	N/A	N/A	DWS Offset (in)	N/A
N/A	Shared Landing?	N/A			
N/A	Gutter Ponding?	N/A	N/A	Gutter Slope (%)	N/A
N/A	Gutter Lip Ht (in)	N/A	N/A	Gutter X Slope (%)	N/A
N/A	Painted X Walk1?	No	N/A	Painted X Walk2?	No
	X Walk 1 Direction	To SW		X Walk 2 Direction	To SE
N/A	X Walk 1 Width (in)	N/A	N/A	X Walk 2 Width (in)	N/A
	X Walk 1 Slope (%)	1.2		X Walk 2 Slope (%)	2.8
	X Walk 1 X Slope (%)	0.6		X Walk 2 X Slope (%)	0.9

N/A	Ramp inside XWalk1?	N/A	N/A	Ramp inside XWalk2?	N/A
	Road Slope (%)	0.3	N/A	Clear Space?	N/A
	Road X Slope (%)	2.1	N/A	Clear Space to XWalk (in)	N/A
N/A	Any Obstructions?	N/A	N/A	Storm Grate/Utility Hazard?	N/A
	Obstruction Type			Storm Grate/Utility Type	
		N/A			N/A
			Yes	Surface Condition? (G/P)	Good

Possible Solutions:

**Remove & Replace Curb Ramp With Two New Directional Ramps or Equivalent.**
