# Access Compliance Report

## Public Rights-of-Way

### (Curb Ramps)

| Intersection ID: 25776 | Main Street: CARMEL_COMMONS_BV | Cross Street: PINEVILLE-MATTHEWS_RD | Location: SE |

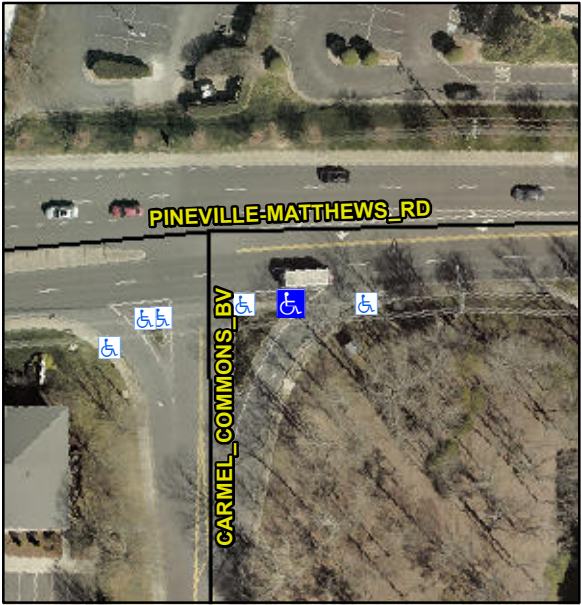
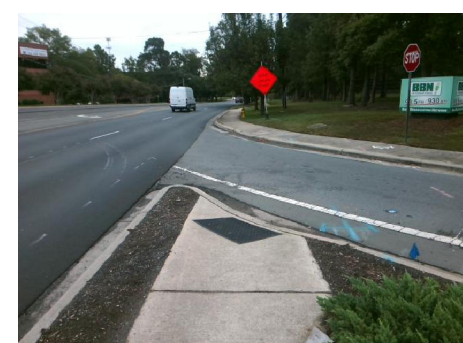
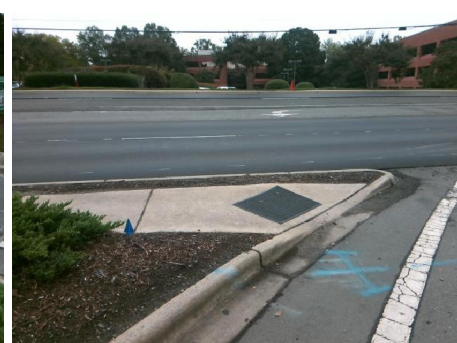
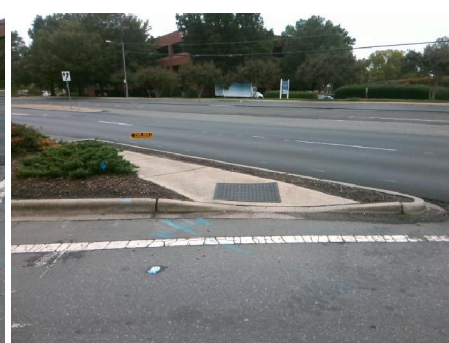
| ADA ID: 3AA4B5BC0356 | Ramp Type: IslandPerp | Initial Pass/Fail: Fail | Overall Compliance: No |
| | | Severity Score: 35 | |

| Codes/Mitigation Info/Possible Solution | | | Field Measurements/Component Compliance | | |
|---|---|--|---|---|---|
| | <b>Remove &amp; Replace Entire Ramp.</b> | | <b>No</b> | Ramp Length (in) | <b>34.0</b> |
| | | | <b>No</b> | Ramp Width (in) | <b>46.0</b> |
| <p>Surveyor Notes:</p> <p><b>N/A</b></p> <p>PROW/ADA:</p> <p><b>Not Found, R304.5.1, R304.2.2, R304.5.3</b></p> | | | <b>N/A</b> | Flare Type RT | <b>N/A</b> |

| Codes/Mitigation Info/Possible Solution | | | Field Measurements/Component Compliance | | |
|---|---|--|---|---|---|
| | Possible Solutions: | | <b>Compliance</b> | <b>Description</b> | <b>Data</b> |
| <p>Total Cost:</p> <p><b>\$ 3400.00</b></p> | | | <b>No</b> | Painted X Walk1? | <b>N/A</b> |
