Access Compliance Report

Public Rights-of-Way

(Curb Ramps)

Intersection ID: 19634	Main Street: E_INDEPENDENCE_BV	Cross Street: KREFELD DR	Location:	N
ADA ID: 3AABCE774F57	Ramp Type: Perp	Initial Pass/Fail: Fail	Overall Compliance: No	Severity Score: 17.5
Codes/Mitigation Info/Possible Solution		Field Measurements/Component Compliance

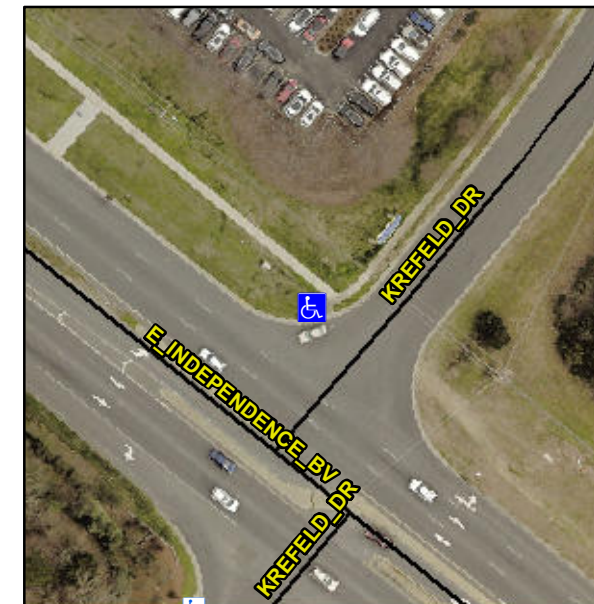
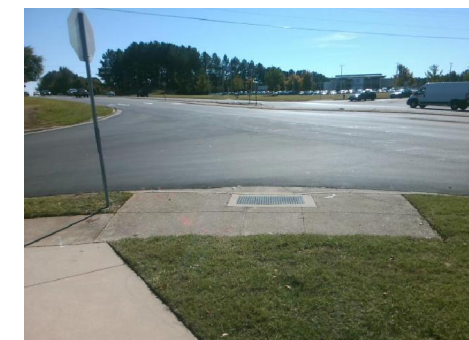
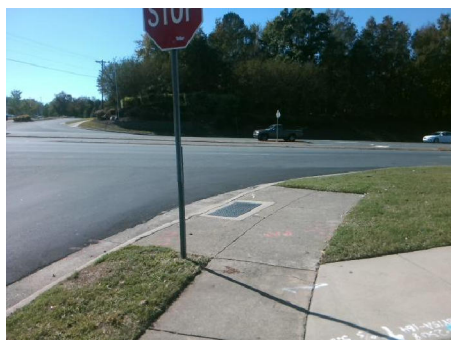
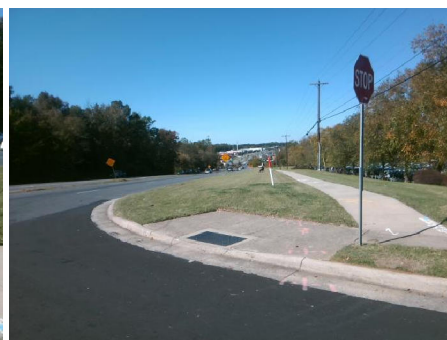
Not Found, R304.5.1

Compliance	Description	Data	Compliance	Description	Data
N/A	Ramp Length (in)	98.0	Yes	Ramp Slope (%)	5.6
No	Ramp Width (in)	34.0	Yes	Ramp XSlope (%)	0.4
N/A	Flare Type LT	N/A	N/A	Flare Type RT	N/A
N/A	Flare Slope LT (%)	N/A	N/A	Flare Slope RT (%)	N/A
N/A	Flare Traversable LT?	N/A	N/A	Flare Traversable RT?	N/A
N/A	Landing Length (in)	N/A	N/A	DWS Provided?	N/A
N/A	Landing Width (in)	N/A	N/A	DWS Contrast?	N/A
N/A	Landing Slope (%)	N/A	N/A	DWS Length (in)	N/A
N/A	Landing X Slope (%)	N/A	N/A	DWS Full Width?	N/A
N/A	Landing Curb? (Y/N)	N/A	N/A	DWS Offset (in)	N/A
N/A	Shared Landing?	N/A			
N/A	Gutter Ponding?	N/A	N/A	Gutter Slope (%)	N/A
N/A	Gutter Lip Ht (in)	N/A	N/A	Gutter X Slope (%)	N/A
N/A	Painted X Walk1?	No	N/A	Painted X Walk2?	N/A
	X Walk 1 Direction	To SE		X Walk 2 Direction	N/A
N/A	X Walk 1 Width (in)	N/A	N/A	X Walk 2 Width (in)	N/A
	X Walk 1 Slope (%)	3.2		X Walk 2 Slope (%)	N/A
	X Walk 1 X Slope (%)	1.6		X Walk 2 X Slope (%)	N/A

N/A	Ramp inside XWalk1?	N/A	N/A	Ramp inside XWalk2?	N/A
	Road Slope (%)	N/A	N/A	Clear Space?	N/A
	Road X Slope (%)	N/A	N/A	Clear Space to XWalk (in)	N/A
N/A	Any Obstructions?	N/A	N/A	Storm Grate/Utility Hazard?	N/A
	Obstruction Type			Storm Grate/Utility Type	
		N/A			N/A
			Yes	Surface Condition? (G/P)	Good

Possible Solutions:

Remove & Replace Entire Ramp.
