# Access Compliance Report

## Public Rights-of-Way

### (Curb Ramps)

| Intersection ID: 13389 | Main Street: ELIZABETH_AV | Cross Street: N_KINGS_DR | Location: N |

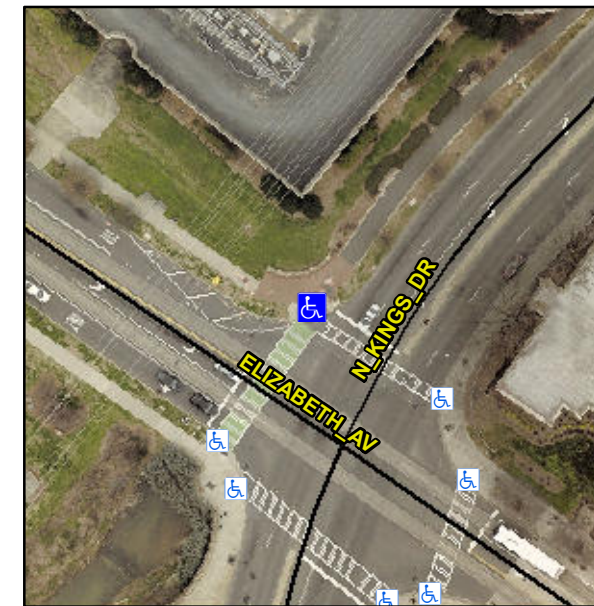
| ADA ID: 3AAFE78FB7ED | Ramp Type: PerpDiag | Initial Pass/Fail: Pass | Overall Compliance: No |

**Not Found, R304.5.3, R305.2**

| Compliance | Description | Data | Compliance | Description | Data |
|---|---|---|---|---|---|
| No | Landing X Slope (%) | 13.0 | Yes | DWS Full Width? | Yes |
| N/A | Landing Curb? (Y/N) | No | No | DWS Offset (in) | 6.0 |

**Remove & Replace Curb Ramp With Two New Directional Ramps or Equivalent.**

Total Cost: \$ 3200.00

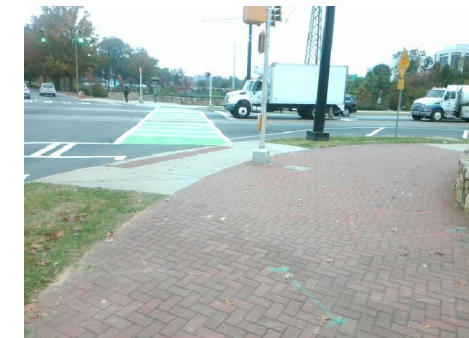
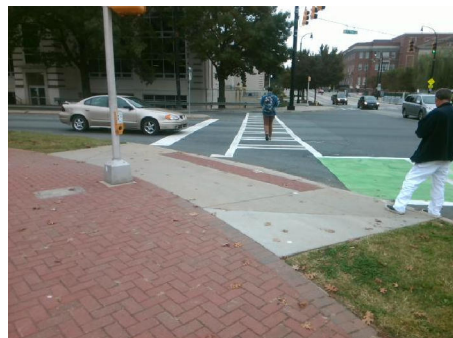
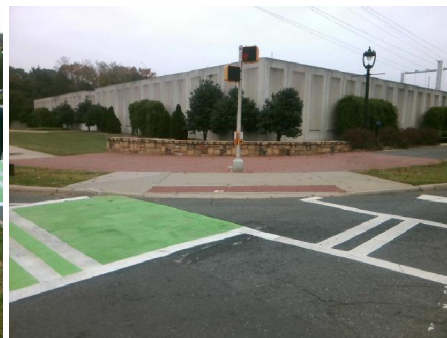
Street 1 Name ELIZABETH AV  
 Stop Condition-Street 2 Signal  
 Street 2 Name N KINGS DR  
 Stop Condition-Street 1 Signal
