Access Compliance Report Public Rights-of-Way (Curb Ramps)

Intersection ID: 47833 Main Street: TOM_SHORT_RD Cross Street: SPUR_RANCH_RD Location: N

ADA ID: 3AB488A3B1F4 Ramp Type: PerpDiag Initial Pass/Fail: Fail Overall Compliance: No Severity Score: 8.75

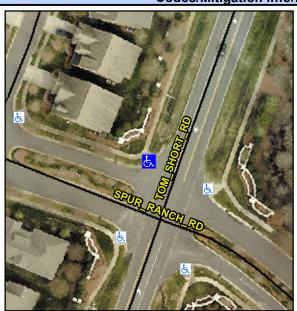
Field Measurements/Component Compliance						
	Compliance Description		Data	Compliance Description		Data
	N/A	Ramp Length (in)	106.0	Yes	Ramp Slope (%)	5.9
	No	Ramp Width (in)	45.0	Yes	Ramp XSlope (%)	0.5
	N/A	Flare Type LT	N/A	N/A	Flare Type RT	N/A
	N/A	Flare Slope LT (%)	N/A	N/A	Flare Slope RT (%)	N/A
	N/A	Flare Traversable LT?	N/A	N/A	Flare Traversable RT?	N/A
	N/A	Landing Length (in)	N/A	N/A	DWS Provided?	N/A
	N/A	Landing Width (in)	N/A	N/A	DWS Contrast?	N/A
	N/A	Landing Slope (%)	N/A	N/A	DWS Length (in)	N/A
	N/A	Landing X Slope (%)	N/A	N/A	DWS Full Width?	N/A
	N/A	Landing Curb? (Y/N)	N/A	N/A	DWS Offset (in)	N/A
	N/A	Shared Landing?	N/A			
	N/A	Gutter Ponding?	N/A	N/A	Gutter Slope (%)	N/A
	N/A	Gutter Lip Ht (in)	N/A	N/A	Gutter X Slope (%)	N/A
	N/A	Painted X Walk1?	No	N/A	Painted X Walk2?	No
		X Walk 1 Direction	To SW		X Walk 2 Direction	To SE
	N/A	X Walk 1 Width (in)	N/A	N/A	X Walk 2 Width (in)	N/A
		X Walk 1 Slope (%)	0.7		X Walk 2 Slope (%)	3.2

X Walk 1 X Slope (%)	1.6		X Walk 2 X Slope (%)	0.3
	N/A	Ramp inside XWalk1?	N/A	N/A	Ramp inside XWalk2?	N/A
		Road Slope (%)	1.1	N/A	Clear Space?	N/A
		Road X Slope (%)	3.5	N/A	Clear Space to XWalk (in)	N/A
				l

Remove & Replace Curb Ramp With
Two New Directional Ramps or
Equivalent.
