Access Compliance Report

Public Rights-of-Way

(Curb Ramps)

Intersection ID: 48714	Main Street: SARDIS_CREEK_LN	Cross Street: KILCULLEN_DR	Location: NW
ADA ID: 3ABB2053AACC	Ramp Type: PerpDiag	Initial Pass/Fail: Fail	Overall Compliance: No
			Severity Score: 21.25

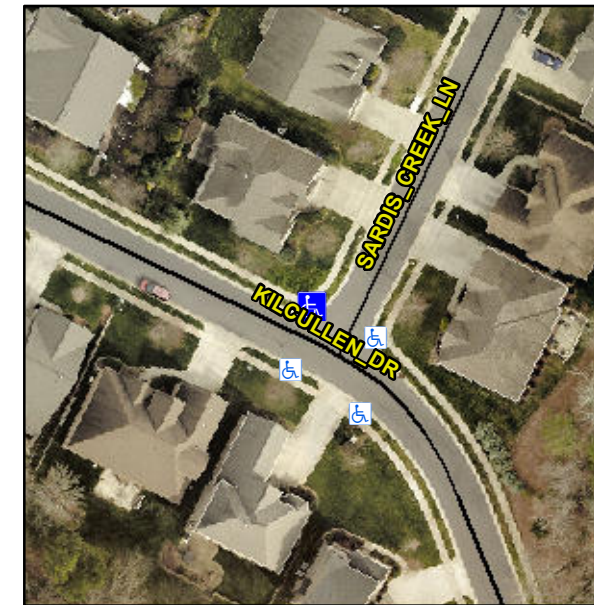
Compliance	Description	Data	Compliance	Description	Data
N/A	Ramp Length (in)	51.0	No	Ramp Slope (%)	9.2
No	Ramp Width (in)	47.0	Yes	Ramp XSlope (%)	0.3
N/A	Flare Type LT	N/A	N/A	Flare Type RT	N/A
N/A	Flare Slope LT (%)	N/A	N/A	Flare Slope RT (%)	N/A
N/A	Flare Traversable LT?	N/A	N/A	Flare Traversable RT?	N/A
N/A	Landing Length (in)	N/A	N/A	DWS Provided?	N/A
N/A	Landing Width (in)	N/A	N/A	DWS Contrast?	N/A
N/A	Landing Slope (%)	N/A	N/A	DWS Length (in)	N/A
N/A	Landing X Slope (%)	N/A	N/A	DWS Full Width?	N/A
N/A	Landing Curb? (Y/N)	N/A	N/A	DWS Offset (in)	N/A
N/A	Shared Landing?	N/A			
N/A	Gutter Ponding?	N/A	N/A	Gutter Slope (%)	N/A
N/A	Gutter Lip Ht (in)	N/A	N/A	Gutter X Slope (%)	N/A
N/A	Painted X Walk1?	No	N/A	Painted X Walk2?	No
	X Walk 1 Direction	To SW		X Walk 2 Direction	To SE
N/A	X Walk 1 Width (in)	N/A	N/A	X Walk 2 Width (in)	N/A
	X Walk 1 Slope (%)	2.3		X Walk 2 Slope (%)	4.2
	X Walk 1 X Slope (%)	3.0		X Walk 2 X Slope (%)	2.5

N/A	Ramp inside XWalk1?	N/A	N/A	Ramp inside XWalk2?	N/A
	Road Slope (%)	0.5	N/A	Clear Space?	N/A
	Road X Slope (%)	5.1	N/A	Clear Space to XWalk (in)	N/A
N/A	Any Obstructions?	N/A	N/A	Storm Grate/Utility Hazard?	N/A
	Obstruction Type			Storm Grate/Utility Type	
		N/A			N/A
			Yes	Surface Condition? (G/P)	Good

Remove & Replace Curb Ramp With Two New Directional Ramps or Equivalent.

R304.5.1, R304.2.2
