Access Compliance Report

Public Rights-of-Way

(Curb Ramps)

Intersection ID: 25263	Main Street: CARPENTER_DR	Cross Street: SHADOWLAKE_DR	Location: S
ADA ID: 3ABBEBC97347	Ramp Type: PerpDiag	Initial Pass/Fail: Fail	Overall Compliance: No
Severity Score: 25			
Codes/Mitigation Info/Possible Solution		Field Measurements/Component Compliance

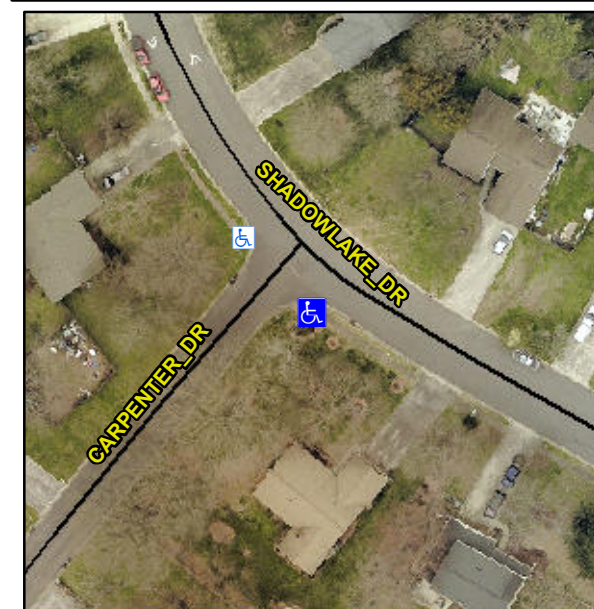
Compliance	Description	Data	Compliance	Description	Data
N/A	Ramp Length (in)	34.0	No	Ramp Slope (%)	13.8
Yes	Ramp Width (in)	48.0	Yes	Ramp XSlope (%)	1.3
N/A	Flare Type LT	N/A	N/A	Flare Type RT	N/A
N/A	Flare Slope LT (%)	N/A	N/A	Flare Slope RT (%)	N/A
N/A	Flare Traversable LT?	N/A	N/A	Flare Traversable RT?	N/A
N/A	Landing Length (in)	N/A	N/A	DWS Provided?	N/A
N/A	Landing Width (in)	N/A	N/A	DWS Contrast?	N/A
N/A	Landing Slope (%)	N/A	N/A	DWS Length (in)	N/A
N/A	Landing X Slope (%)	N/A	N/A	DWS Full Width?	N/A
N/A	Landing Curb? (Y/N)	N/A	N/A	DWS Offset (in)	N/A
N/A	Shared Landing?	N/A			
N/A	Gutter Ponding?	N/A	N/A	Gutter Slope (%)	N/A
N/A	Gutter Lip Ht (in)	N/A	N/A	Gutter X Slope (%)	N/A
N/A	Painted X Walk1?	No	N/A	Painted X Walk2?	No
	X Walk 1 Direction	To NE		X Walk 2 Direction	To NW
N/A	X Walk 1 Width (in)	N/A	N/A	X Walk 2 Width (in)	N/A
	X Walk 1 Slope (%)	7.5		X Walk 2 Slope (%)	4.0
	X Walk 1 X Slope (%)	3.6		X Walk 2 X Slope (%)	7.8

N/A	Ramp inside XWalk1?	N/A	N/A	Ramp inside XWalk2?	N/A
	Road Slope (%)	2.1	N/A	Clear Space?	N/A
	Road X Slope (%)	10.0	N/A	Clear Space to XWalk (in)	N/A
N/A	Any Obstructions?	N/A	N/A	Storm Grate/Utility Hazard?	N/A
	Obstruction Type			Storm Grate/Utility Type	
		N/A			N/A
			Yes	Surface Condition? (G/P)	Good

Possible Solutions:

Remove & Replace Curb Ramp With Two New Directional Ramps or Equivalent.
