# Access Compliance Report

## Public Rights-of-Way

### (Curb Ramps)

Intersection ID: 21731	Main Street: BRITTANY_CT	Cross Street: INTERNATIONAL_DR	Location: S
ADA ID: 3AC25610A5F1	Ramp Type: PerpDiag	Initial Pass/Fail: Fail	Overall Compliance: No
		Severity Score: 58.75

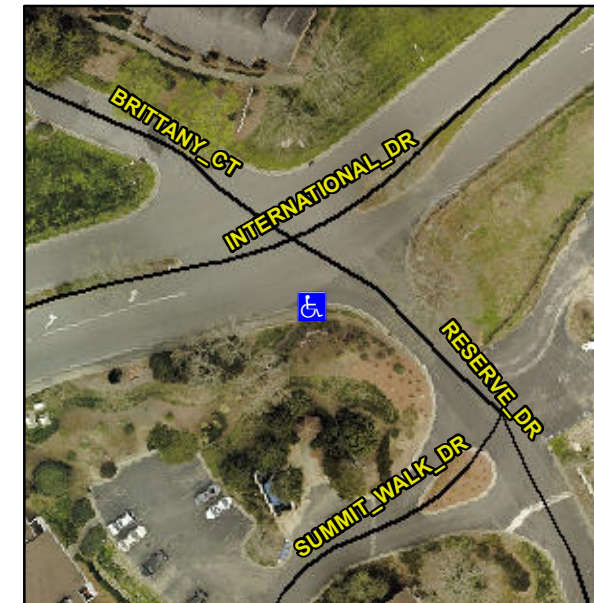
**Not Found, R304.5.1, R304.2.2, R304.5.3**

Compliance	Description	Data	Compliance	Description	Data
N/A	Ramp Length (in)	26.0	No	Ramp Slope (%)	15.5
No	Ramp Width (in)	46.0	No	Ramp XSlope (%)	14.9
N/A	Flare Type LT	N/A	N/A	Flare Type RT	N/A
N/A	Flare Slope LT (%)	N/A	N/A	Flare Slope RT (%)	N/A
N/A	Flare Traversable LT?	N/A	N/A	Flare Traversable RT?	N/A
N/A	Landing Length (in)	N/A	N/A	DWS Provided?	N/A
N/A	Landing Width (in)	N/A	N/A	DWS Contrast?	N/A
N/A	Landing Slope (%)	N/A	N/A	DWS Length (in)	N/A
N/A	Landing X Slope (%)	N/A	N/A	DWS Full Width?	N/A
N/A	Landing Curb? (Y/N)	N/A	N/A	DWS Offset (in)	N/A
N/A	Shared Landing?	N/A			
N/A	Gutter Ponding?	N/A	N/A	Gutter Slope (%)	N/A
N/A	Gutter Lip Ht (in)	N/A	N/A	Gutter X Slope (%)	N/A
N/A	Painted X Walk1?	No	N/A	Painted X Walk2?	No
	X Walk 1 Direction	To E		X Walk 2 Direction	To N
N/A	X Walk 1 Width (in)	N/A	N/A	X Walk 2 Width (in)	N/A
	X Walk 1 Slope (%)	12.8		X Walk 2 Slope (%)	5.7
	X Walk 1 X Slope (%)	4.8		X Walk 2 X Slope (%)	12.3

N/A	Ramp inside XWalk1?	N/A	N/A	Ramp inside XWalk2?	N/A
	Road Slope (%)	13.0	N/A	Clear Space?	N/A
	Road X Slope (%)	0.9	N/A	Clear Space to XWalk (in)	N/A
N/A	Any Obstructions?	N/A	N/A	Storm Grate/Utility Hazard?	N/A
	Obstruction Type			Storm Grate/Utility Type	
		N/A			N/A
			Yes	Surface Condition? (G/P)	Good

**Remove & Replace Curb Ramp With Two New Directional Ramps or Equivalent.**
