# Access Compliance Report

## Public Rights-of-Way

### (Curb Ramps)

| Intersection ID: 9789 | Main Street: N_POPLAR_ST | Cross Street: W_28TH_ST | Location: S |

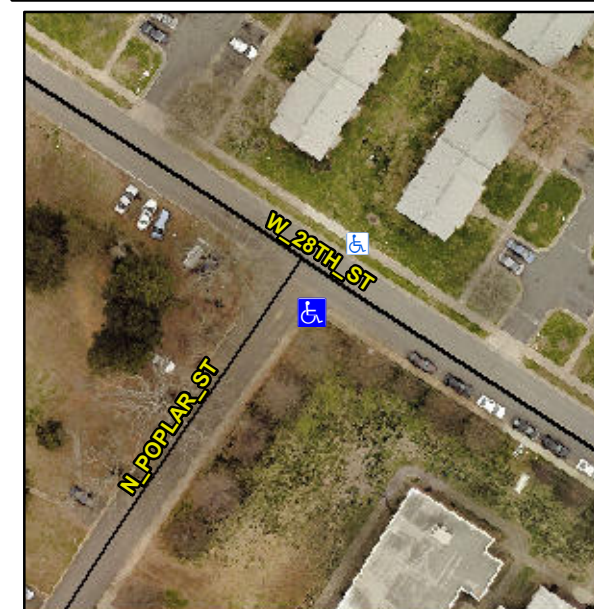
| ADA ID: 3ACD4C9C7297 | Ramp Type: Perp | Initial Pass/Fail: Fail | Overall Compliance: No |
| Severity Score: 21.25 | | | |

**Not Found, R304.5.1, R304.2.2**

| Compliance | Description | Data | Compliance | Description | Data |
|---|---|---|---|---|---|
| N/A | Ramp Length (in) | 48.0 | No | Ramp Slope (%) | 10.4 |
| No | Ramp Width (in) | 37.0 | Yes | Ramp XSlope (%) | 0.5 |
| N/A | Gutter Ponding? | Yes | N/A | Gutter Slope (%) | N/A |
| N/A | Gutter Lip Ht (in) | 1.0 | N/A | Gutter X Slope (%) | N/A |

Possible Solutions:

**Remove & Replace Entire Ramp.**

Total Cost: \$ 1850.00
