Access Compliance Report Public Rights-of-Way (Curb Ramps)

Intersection ID: 21780 Main Street: SHARON_RD Cross Street: QUAIL_HOLLOW_RD Location: SE **Overall Compliance: No** Severity Score: 13.75 ADA ID: 3ACE8030565E Ramp Type: Perp Initial Pass/Fail: Fail

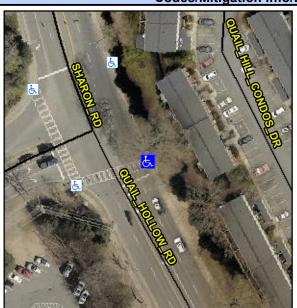
Field Measurements/Component Compliance								
Compl	liance Description	Data	Comp	liance Description	Data			
N/A	Ramp Length (in)	58.0	No	Ramp Slope (%)	9.2			
Yes	Ramp Width (in)	48.0	No	Ramp XSlope (%)	3.1			
N/A	Flare Type LT	N/A	N/A	N/A Flare Type RT				
N/A	Flare Slope LT (%)	N/A	N/A	Flare Slope RT (%)	N/A			
N/A	Flare Traversable LT?	N/A	N/A	Flare Traversable RT?	N/A			
N/A	Landing Length (in)	N/A	N/A	DWS Provided?	N/A			
N/A	Landing Width (in)	N/A	N/A	DWS Contrast?	N/A			
N/A	Landing Slope (%)	N/A	N/A	DWS Length (in)	N/A			
N/A	Landing X Slope (%)	N/A	N/A	DWS Full Width?	N/A			
N/A	Landing Curb? (Y/N)	N/A	N/A	DWS Offset (in)	N/A			
N/A	Shared Landing?	N/A						
N/A	Gutter Ponding?	N/A	N/A	Gutter Slope (%)	N/A			
N/A	Gutter Lip Ht (in)	N/A	N/A	Gutter X Slope (%)	N/A			
N/A	Painted X Walk1?	Yes	N/A	Painted X Walk2?	N/A			
	X Walk 1 Direction	To W		X Walk 2 Direction	N/A			
N/A	X Walk 1 Width (in)	109.0	N/A	X Walk 2 Width (in)	N/A

X Walk 1 Slope (%)	2.9		X Walk 2 Slope (%)	N/A			
	X Walk 1 X Slope (%)	2.7		X Walk 2 X Slope (%)	N/A			
N/A	Ramp inside XWalk1?	Yes	N/A	Ramp inside XWalk2?	N/A			
	Road Slope (%)	N/A	N/A	Clear Space?	N/A			
	Road X Slope (%)	N/A	N/A	Clear Space to XWalk (in)	N/A			
N/A	Any Obstructions?	N/A	N/A	Storm Grate/Utility Hazard?	N/A			
	Obstruction Type			Storm Grate/Utility Type				
		N/A			N/A			
			Yes	Surface Condition? (G/P)	Good

i ossible solution	
Possible Solutions:	
Remove & Replace Entire Ramp.	N
·	١
	N
	N
	1
	N
Surveyor Notes:	N
N/A	1
	1
	ı
	N
PROW/ADA:	1
Not Found, R304.2.2, R304.5.3	N
	N
	ı

Total Cost:		\$ 1850.00
