# Access Compliance Report

## Public Rights-of-Way (Curb Ramps)

| Intersection ID: 42675 | Main Street: WALLACE_CABIN_DR | Cross Street: WALLACE_GLEN_DR | Location: SW |
| ADA ID: 3ACEDCF9712F | Ramp Type: BlendTrans1 | Initial Pass/Fail: Fail | Overall Compliance: No |

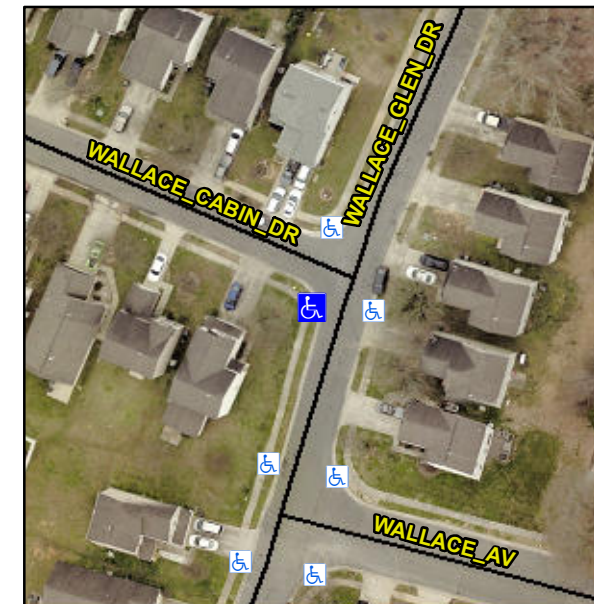
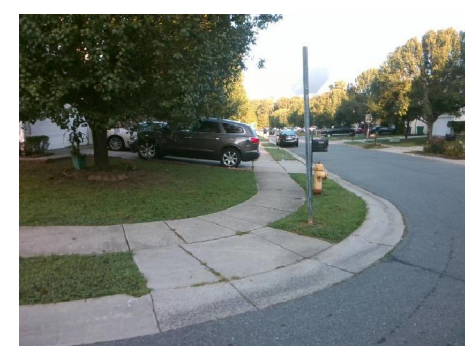
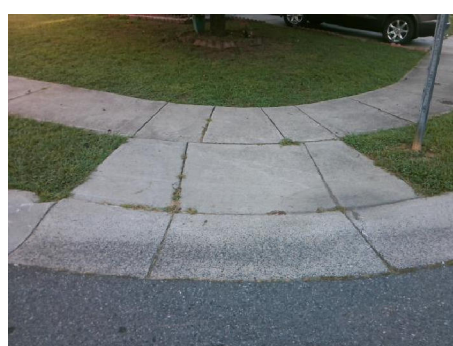
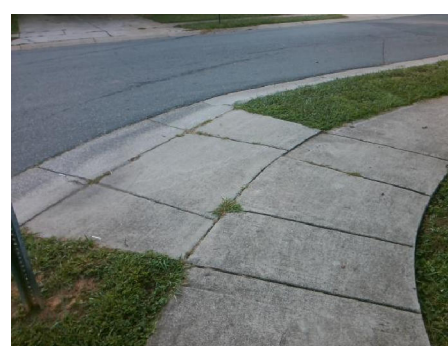
| | | Severity Score: 10 | |

**R304.5.1, R304.5.3**

| Compliance | Description | Data | Compliance | Description | Data |
|---|---|---|---|---|---|
| No | Ramp Width (in) | 47.0 | No | BlendTrans XSlope (%) | 4.2 |

**Remove & Replace Curb Ramp With Two New Directional Ramps or Equivalent.**

Total Cost: \$ 3200.00
