Access Compliance Report

Public Rights-of-Way (Curb Ramps)

Intersection ID: 21035	Main Street: RUSTIC_LN	Cross Street: SHARON_VIEW_RD	Location: SE
ADA ID: 3ADDDC551026	Ramp Type: PerpDiag	Initial Pass/Fail: Fail	Overall Compliance: No Severity Score: 33.75

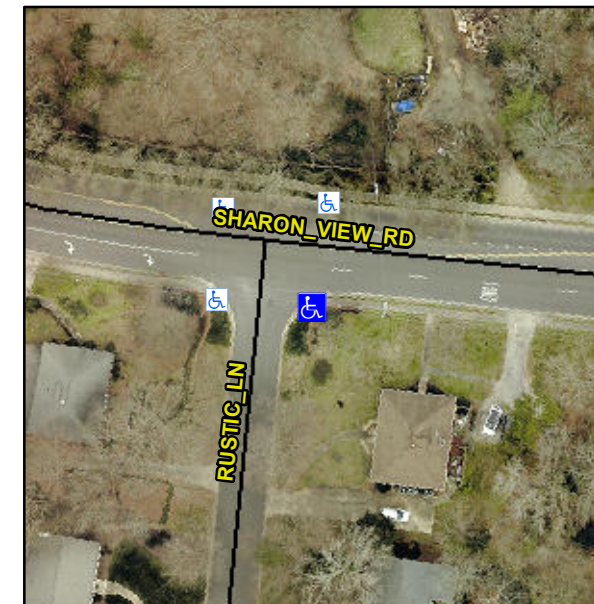
Not Found, R304.5.1, R304.2.2, R304.5.3

Compliance	Description	Data	Compliance	Description	Data
N/A	Ramp Length (in)	61.0	No	Ramp Slope (%)	11.2
No	Ramp Width (in)	40.0	No	Ramp XSlope (%)	5.5
N/A	Flare Type LT	N/A	N/A	Flare Type RT	N/A
N/A	Flare Slope LT (%)	N/A	N/A	Flare Slope RT (%)	N/A
N/A	Flare Traversable LT?	N/A	N/A	Flare Traversable RT?	N/A
N/A	Landing Length (in)	N/A	N/A	DWS Provided?	N/A
N/A	Landing Width (in)	N/A	N/A	DWS Contrast?	N/A
N/A	Landing Slope (%)	N/A	N/A	DWS Length (in)	N/A
N/A	Landing X Slope (%)	N/A	N/A	DWS Full Width?	N/A
N/A	Landing Curb? (Y/N)	N/A	N/A	DWS Offset (in)	N/A
N/A	Shared Landing?	N/A			
N/A	Gutter Ponding?	N/A	N/A	Gutter Slope (%)	N/A
N/A	Gutter Lip Ht (in)	N/A	N/A	Gutter X Slope (%)	N/A
N/A	Painted X Walk1?	No	N/A	Painted X Walk2?	No
	X Walk 1 Direction	To NE		X Walk 2 Direction	To NW
N/A	X Walk 1 Width (in)	N/A	N/A	X Walk 2 Width (in)	N/A
	X Walk 1 Slope (%)	3.0		X Walk 2 Slope (%)	5.7
	X Walk 1 X Slope (%)	5.6		X Walk 2 X Slope (%)	1.1

N/A	Ramp inside XWalk1?	N/A	N/A	Ramp inside XWalk2?	N/A
	Road Slope (%)	6.0	N/A	Clear Space?	N/A
	Road X Slope (%)	2.1	N/A	Clear Space to XWalk (in)	N/A
N/A	Any Obstructions?	N/A	N/A	Storm Grate/Utility Hazard?	N/A
	Obstruction Type			Storm Grate/Utility Type	
		N/A			N/A
			Yes	Surface Condition? (G/P)	Good

Remove & Replace Curb Ramp With Two New Directional Ramps or Equivalent.

Total Cost: \$ 3200.00
