Access Compliance Report

Public Rights-of-Way

(Curb Ramps)

Intersection ID: 28345		Main Street: BACARDI_CT		Cross Street: HIRSCH_DR		Location: NE			
ADA ID: 3AE791B50603		Ramp Type: Perp		Initial Pass/Fail: Fail		Overall Compliance: No		Severity Score: 10	
Codes/Mitigation Info/Possible Solution				Field Measurements/Component Compliance

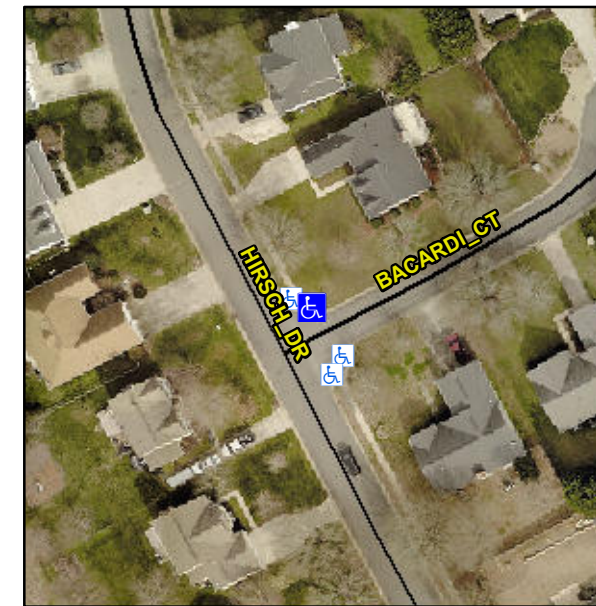
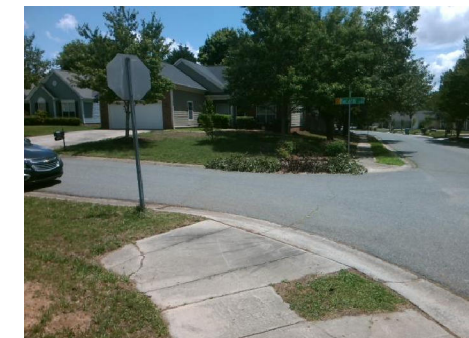
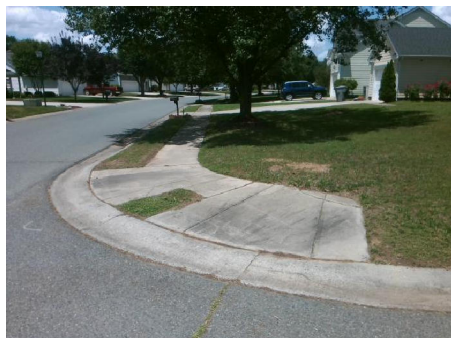
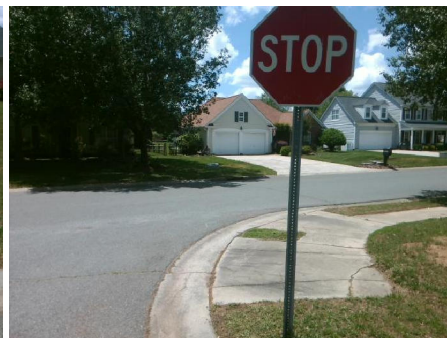
Not Found, R304.5.1, R304.5.3

Compliance	Description	Data	Compliance	Description	Data
N/A	Ramp Length (in)	97.0	Yes	Ramp Slope (%)	5.6
No	Ramp Width (in)	36.0	No	Ramp XSlope (%)	3.0
N/A	Flare Type LT	N/A	N/A	Flare Type RT	N/A
N/A	Flare Slope LT (%)	N/A	N/A	Flare Slope RT (%)	N/A
N/A	Flare Traversable LT?	N/A	N/A	Flare Traversable RT?	N/A
N/A	Landing Length (in)	N/A	N/A	DWS Provided?	N/A
N/A	Landing Width (in)	N/A	N/A	DWS Contrast?	N/A
N/A	Landing Slope (%)	N/A	N/A	DWS Length (in)	N/A
N/A	Landing X Slope (%)	N/A	N/A	DWS Full Width?	N/A
N/A	Landing Curb? (Y/N)	N/A	N/A	DWS Offset (in)	N/A
N/A	Shared Landing?	N/A			
N/A	Gutter Ponding?	N/A	N/A	Gutter Slope (%)	N/A
N/A	Gutter Lip Ht (in)	N/A	N/A	Gutter X Slope (%)	N/A
N/A	Painted X Walk1?	No	N/A	Painted X Walk2?	N/A
	X Walk 1 Direction	To SE		X Walk 2 Direction	N/A
N/A	X Walk 1 Width (in)	N/A	N/A	X Walk 2 Width (in)	N/A
	X Walk 1 Slope (%)	0.5		X Walk 2 Slope (%)	N/A
	X Walk 1 X Slope (%)	2.0		X Walk 2 X Slope (%)	N/A

N/A	Ramp inside XWalk1?	N/A	N/A	Ramp inside XWalk2?	N/A
	Road Slope (%)	N/A	N/A	Clear Space?	N/A
	Road X Slope (%)	N/A	N/A	Clear Space to XWalk (in)	N/A
N/A	Any Obstructions?	N/A	N/A	Storm Grate/Utility Hazard?	N/A
	Obstruction Type			Storm Grate/Utility Type	
		N/A			N/A
			Yes	Surface Condition? (G/P)	Good

Remove & Replace Entire Ramp.
