Access Compliance Report

Public Rights-of-Way

(Curb Ramps)

Intersection ID: 10025367	Main Street: E_8TH_ST	Cross Street: N/A	Location: W
ADA ID: 3AE7D740AEEC	Ramp Type: Perp	Initial Pass/Fail: Pass	Overall Compliance: No
Severity Score: 2.5			
Codes/Mitigation Info/Possible Solution		Field Measurements/Component Compliance

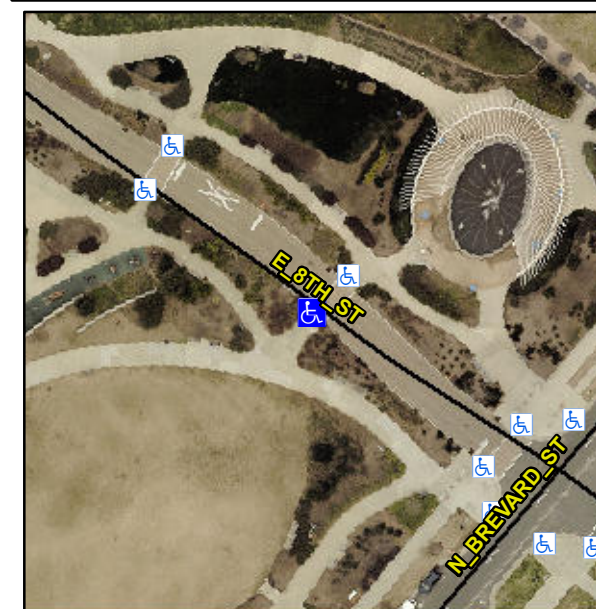
Compliance	Description	Data	Compliance	Description	Data
N/A	Ramp Length (in)	90.0	Yes	Ramp Slope (%)	6.3
Yes	Ramp Width (in)	75.0	Yes	Ramp XSlope (%)	1.4
N/A	Flare Type LT	None	N/A	Flare Type RT	N/A
N/A	Flare Slope LT (%)	N/A	N/A	Flare Slope RT (%)	N/A
N/A	Flare Traversable LT?	N/A	N/A	Flare Traversable RT?	N/A
Yes	Landing Length (in)	48.0	Yes	DWS Provided?	Yes
Yes	Landing Width (in)	48.0	Yes	DWS Contrast?	Yes
No	Landing Slope (%)	2.2	Yes	DWS Length (in)	24.0
Yes	Landing X Slope (%)	1.4	No	DWS Full Width?	No
N/A	Landing Curb? (Y/N)	No	Yes	DWS Offset (in)	0.0
N/A	Shared Landing?	No			
Yes	Gutter Ponding?	No	Yes	Gutter Slope (%)	2.4
Yes	Gutter Lip Ht (in)	0.0	No	Gutter X Slope (%)	2.5
N/A	Painted X Walk1?	Yes	N/A	Painted X Walk2?	N/A
	X Walk 1 Direction	To NE		X Walk 2 Direction	N/A
N/A	X Walk 1 Width (in)	120.0	N/A	X Walk 2 Width (in)	N/A
	X Walk 1 Slope (%)	1.4		X Walk 2 Slope (%)	N/A
	X Walk 1 X Slope (%)	2.4		X Walk 2 X Slope (%)	N/A

Yes	Ramp inside XWalk1?	Yes	N/A	Ramp inside XWalk2?	N/A
	Road Slope (%)	N/A	N/A	Clear Space?	Yes
	Road X Slope (%)	N/A	N/A	Clear Space to XWalk (in)	N/A
Yes	Any Obstructions?	No	Yes	Storm Grate/Utility Hazard?	No
	Obstruction Type			Storm Grate/Utility Type	
		N/A			N/A
			Yes	Surface Condition? (G/P)	Good

Possible Solutions:

**Remove & Replace Entire Ramp.
Remove & Replace Gutter.**

**R304.2.2-Perp, R304.3.2-Para,
R305.1.4, R304.5.3**
