Access Compliance Report

Public Rights-of-Way

(Curb Ramps)

Intersection ID: 19453	Main Street: ALDERSHOT_CT	Cross Street: KINGSGATE_PL	Location: SW
ADA ID: 3AEA33662411	Ramp Type: PerpDiag	Initial Pass/Fail: Fail	Overall Compliance: No
		Severity Score: 12.5

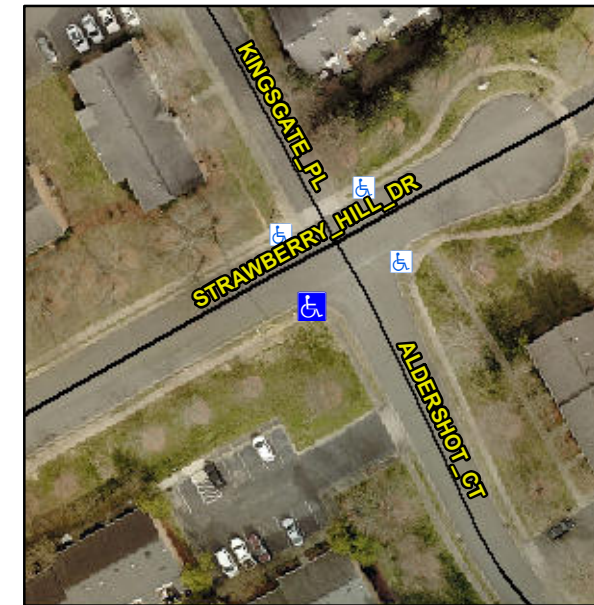
Not Found, R304.2.2

Compliance	Description	Data	Compliance	Description	Data
N/A	Ramp Length (in)	69.0	No	Ramp Slope (%)	11.5
Yes	Ramp Width (in)	48.0	Yes	Ramp XSlope (%)	0.1
N/A	Flare Type LT	N/A	N/A	Flare Type RT	N/A
N/A	Flare Slope LT (%)	N/A	N/A	Flare Slope RT (%)	N/A
N/A	Flare Traversable LT?	N/A	N/A	Flare Traversable RT?	N/A
N/A	Landing Length (in)	N/A	N/A	DWS Provided?	N/A
N/A	Landing Width (in)	N/A	N/A	DWS Contrast?	N/A
N/A	Landing Slope (%)	N/A	N/A	DWS Length (in)	N/A
N/A	Landing X Slope (%)	N/A	N/A	DWS Full Width?	N/A
N/A	Landing Curb? (Y/N)	N/A	N/A	DWS Offset (in)	N/A
N/A	Shared Landing?	N/A			
N/A	Gutter Ponding?	N/A	N/A	Gutter Slope (%)	N/A
N/A	Gutter Lip Ht (in)	N/A	N/A	Gutter X Slope (%)	N/A
N/A	Painted X Walk1?	No	N/A	Painted X Walk2?	No
	X Walk 1 Direction	To NE		X Walk 2 Direction	To NW
N/A	X Walk 1 Width (in)	N/A	N/A	X Walk 2 Width (in)	N/A
	X Walk 1 Slope (%)	0.8		X Walk 2 Slope (%)	0.8
	X Walk 1 X Slope (%)	2.8		X Walk 2 X Slope (%)	0.5

N/A	Ramp inside XWalk1?	N/A	N/A	Ramp inside XWalk2?	N/A
	Road Slope (%)	1.0	N/A	Clear Space?	N/A
	Road X Slope (%)	2.5	N/A	Clear Space to XWalk (in)	N/A
N/A	Any Obstructions?	N/A	N/A	Storm Grate/Utility Hazard?	N/A
	Obstruction Type			Storm Grate/Utility Type	
		N/A			N/A
			Yes	Surface Condition? (G/P)	Good

Remove & Replace Curb Ramp With Two New Directional Ramps or Equivalent.
