# Access Compliance Report

## Public Rights-of-Way

### (Curb Ramps)

Intersection ID: 48161	Main Street: HEWITT_ASSOCIATES_DR	Cross Street: IBM_DR	Location:	E
ADA ID: 3AF2184B86FB	Ramp Type: Perp	Initial Pass/Fail: Fail	Overall Compliance: No	Severity Score: 8.75
Codes/Mitigation Info/Possible Solution		Field Measurements/Component Compliance

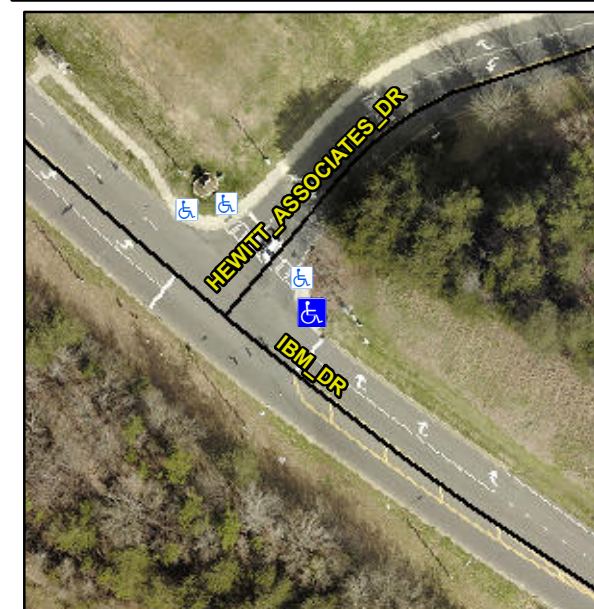
**Not Found, R304.5.1**

Compliance	Description	Data	Compliance	Description	Data
N/A	Ramp Length (in)	59.0	Yes	Ramp Slope (%)	7.4
No	Ramp Width (in)	47.0	Yes	Ramp XSlope (%)	1.2
N/A	Flare Type LT	N/A	N/A	Flare Type RT	N/A
N/A	Flare Slope LT (%)	N/A	N/A	Flare Slope RT (%)	N/A
N/A	Flare Traversable LT?	N/A	N/A	Flare Traversable RT?	N/A
N/A	Landing Length (in)	N/A	N/A	DWS Provided?	N/A
N/A	Landing Width (in)	N/A	N/A	DWS Contrast?	N/A
N/A	Landing Slope (%)	N/A	N/A	DWS Length (in)	N/A
N/A	Landing X Slope (%)	N/A	N/A	DWS Full Width?	N/A
N/A	Landing Curb? (Y/N)	N/A	N/A	DWS Offset (in)	N/A
N/A	Shared Landing?	N/A			
N/A	Gutter Ponding?	N/A	N/A	Gutter Slope (%)	N/A
N/A	Gutter Lip Ht (in)	N/A	N/A	Gutter X Slope (%)	N/A
N/A	Painted X Walk1?	No	N/A	Painted X Walk2?	N/A
	X Walk 1 Direction	To W		X Walk 2 Direction	N/A
N/A	X Walk 1 Width (in)	N/A	N/A	X Walk 2 Width (in)	N/A
	X Walk 1 Slope (%)	5.5		X Walk 2 Slope (%)	N/A
	X Walk 1 X Slope (%)	2.2		X Walk 2 X Slope (%)	N/A

N/A	Ramp inside XWalk1?	N/A	N/A	Ramp inside XWalk2?	N/A
	Road Slope (%)	N/A	N/A	Clear Space?	N/A
	Road X Slope (%)	N/A	N/A	Clear Space to XWalk (in)	N/A
N/A	Any Obstructions?	N/A	N/A	Storm Grate/Utility Hazard?	N/A
	Obstruction Type			Storm Grate/Utility Type	
		N/A			N/A
			Yes	Surface Condition? (G/P)	Good

**Remove & Replace Entire Ramp.**

Total Cost: \$ 1850.00
