Access Compliance Report

Public Rights-of-Way

(Curb Ramps)

Intersection ID: 48416	Main Street: YORK_CROSSING_DR	Cross Street: S_TRYON_ST	Location: SW
ADA ID: 3AF50E019618	Ramp Type: Perp	Initial Pass/Fail: Fail	Overall Compliance: No
Severity Score: 12.5			
Codes/Mitigation Info/Possible Solution		Field Measurements/Component Compliance

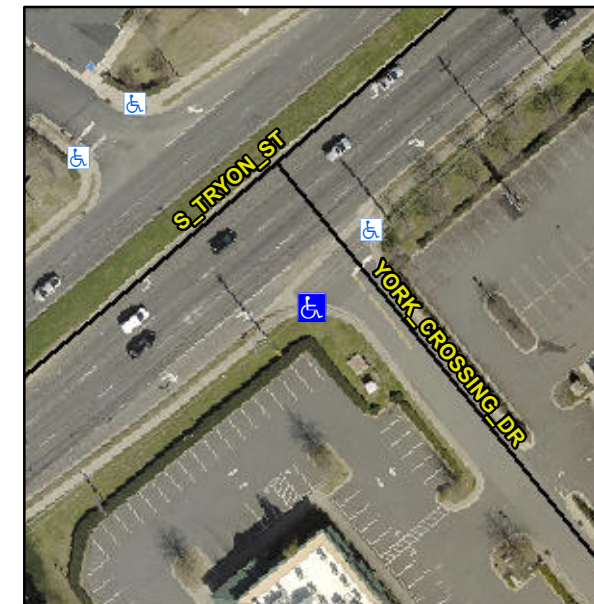
Compliance	Description	Data	Compliance	Description	Data
N/A	Ramp Length (in)	59.0	Yes	Ramp Slope (%)	7.6
Yes	Ramp Width (in)	48.0	No	Ramp XSlope (%)	5.5
N/A	Flare Type LT	N/A	N/A	Flare Type RT	N/A
N/A	Flare Slope LT (%)	N/A	N/A	Flare Slope RT (%)	N/A
N/A	Flare Traversable LT?	N/A	N/A	Flare Traversable RT?	N/A
N/A	Landing Length (in)	N/A	N/A	DWS Provided?	N/A
N/A	Landing Width (in)	N/A	N/A	DWS Contrast?	N/A
N/A	Landing Slope (%)	N/A	N/A	DWS Length (in)	N/A
N/A	Landing X Slope (%)	N/A	N/A	DWS Full Width?	N/A
N/A	Landing Curb? (Y/N)	N/A	N/A	DWS Offset (in)	N/A
N/A	Shared Landing?	N/A			
N/A	Gutter Ponding?	N/A	N/A	Gutter Slope (%)	N/A
N/A	Gutter Lip Ht (in)	N/A	N/A	Gutter X Slope (%)	N/A
N/A	Painted X Walk1?	No	N/A	Painted X Walk2?	N/A
	X Walk 1 Direction	To NE		X Walk 2 Direction	N/A
N/A	X Walk 1 Width (in)	N/A	N/A	X Walk 2 Width (in)	N/A
	X Walk 1 Slope (%)	1.8		X Walk 2 Slope (%)	N/A
	X Walk 1 X Slope (%)	4.0		X Walk 2 X Slope (%)	N/A

N/A	Ramp inside XWalk1?	N/A	N/A	Ramp inside XWalk2?	N/A
	Road Slope (%)	N/A	N/A	Clear Space?	N/A
	Road X Slope (%)	N/A	N/A	Clear Space to XWalk (in)	N/A
N/A	Any Obstructions?	N/A	N/A	Storm Grate/Utility Hazard?	N/A
	Obstruction Type			Storm Grate/Utility Type	
		N/A			N/A
		Yes		Surface Condition? (G/P)	Good

Possible Solutions:

Remove & Replace Entire Ramp.

PROW/ADA:

R304.5.3
